## Significant Incident Report No. 264

**Subject:** Solvent vapour explosion during engine maintenance task

**Date:** 06 July 2018

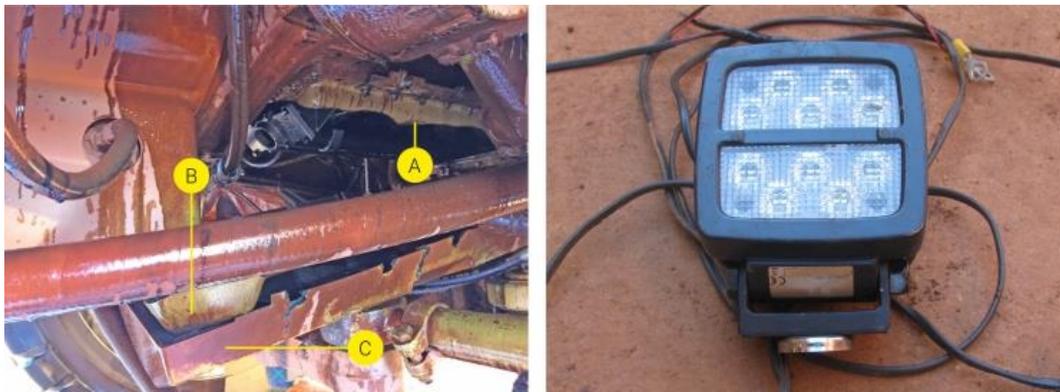
A 12 volt LED lamp with a magnetic base was used to illuminate the work area. The technician used a brake cleaning solvent to clean up the task area, and the solvent vapours (heavier than air) built up within the confines of the engine and accumulated in the sump. The lamp was accidentally dislodged and fell, causing a spark that ignited the vapours and resulted in an explosion.

The cast iron sump disintegrated as a result of the explosion and the technician received burns to his face.

- Flammable solvent vapours built up in the engine and were ignited by a 12 volt LED lamp connected directly to the truck battery.

Left: Sump damage, showing the failed sump (A) and the sump remnant (B) that had fallen down into the sump cover (C). Right: LED lamp used to illuminate the work area.

- Where possible, eliminate the use of flammable cleaning agents.

- Use only products and equipment that are fit for purpose (e.g. lighting, cleaning products).
- Routine tasks should be undertaken using an approved safe work instruction (SWI).
- Before using chemical products, refer to safety data sheets and other safety information in the site's hazardous substances register.
- Ensure restricted areas, where required, are adequately ventilated.
