# NZ Safety Alert

## Faulty pressure gauge

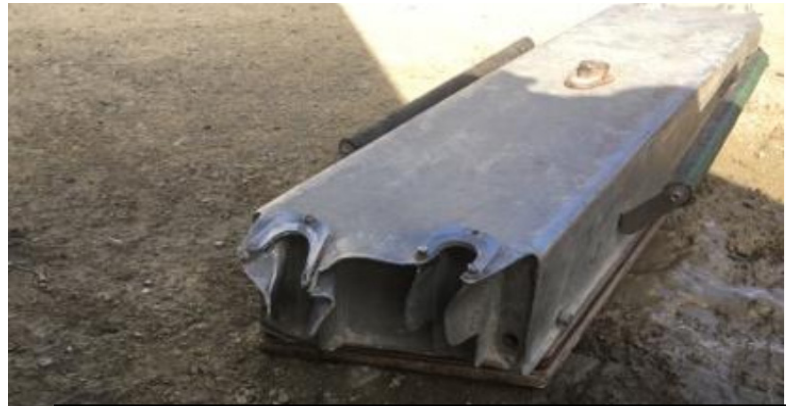
A subcontractor was performing splicing of a conveyor belt (joining the belt with pressure and heat) on a mobile crushing plant when a clamping bolt on the vulcaniser failed and part of the vulcaniser catapulted around 5 metres into the air. The part, weighing approximately 50kgs, landed on the back end of the contractor's van and smashed the rear window.

An investigation found that the vulcaniser had a faulty pressure gauge, resulting in the vulcaniser being pressurized to 150 PSI, almost twice the normal pressure of 90 PSI.

Top half of the vulcaniser where it has been bent while it catapulted off the belt

1. Regular and appropriate checks are made of all pressure gauges. Monthly inspections include pressure vessels and gauges.
2. Where practical, compressors are fitted with pressure gauges so that a secondary check system is maintained.
3. Appropriate checks are made of equipment supplied and used by contractors to ensure it is fit for purpose.
4. Workers, including contractors, are trained and assessed as competent to operate pressurised systems and equipment.
