# NZ Safety Alert

May 2019

## Loader over-balance incident

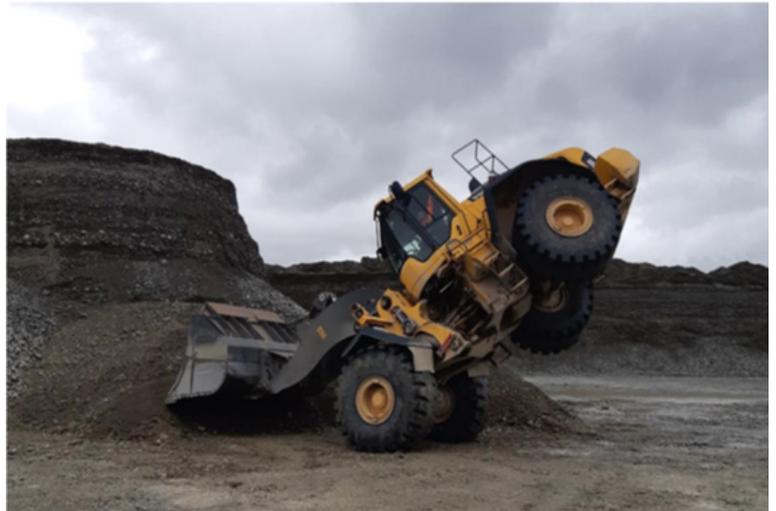
A Volvo L250H loader was delivering a bucket full of sand to an aggregate blending stockpile. As the loader approached the mixing point the operator began to raise the bucket in preparation to unload the bucket. The center of gravity shifted too far forward, beyond the limits of the counterweights' effectiveness and the loader slowly came to rest on its bucket and front wheels, the rear wheels being in the air. The body of the loader was slightly off center to the operator's right when it experienced the overbalancing event. A bund was established behind the loader to avoid it tipping, and the operator was able to right the loader.

The operator had picked up the same volume of material as per previous loads, however heavy rain during morning tea break could have contributed to the heavier load.

1. Your site establishes the maximum lifting load for each piece of mobile plant, taking into consideration different articulations and heights of lifting (OEM manuals may assist).
2. The Safe Weight Lifting load is clearly displayed for each piece of plant and in each situation.
3. Consideration is given to environmental conditions such as heavy rain, and impact on load weights.
4. Operators are adequately trained and competent to operate mobile equipment in all circumstances and conditions.
