## Serious injury

**Event:** Serious injury at open cut coal mine

**Location:** Werris Creek No 2 Coal Mine, Werris Creek NSW

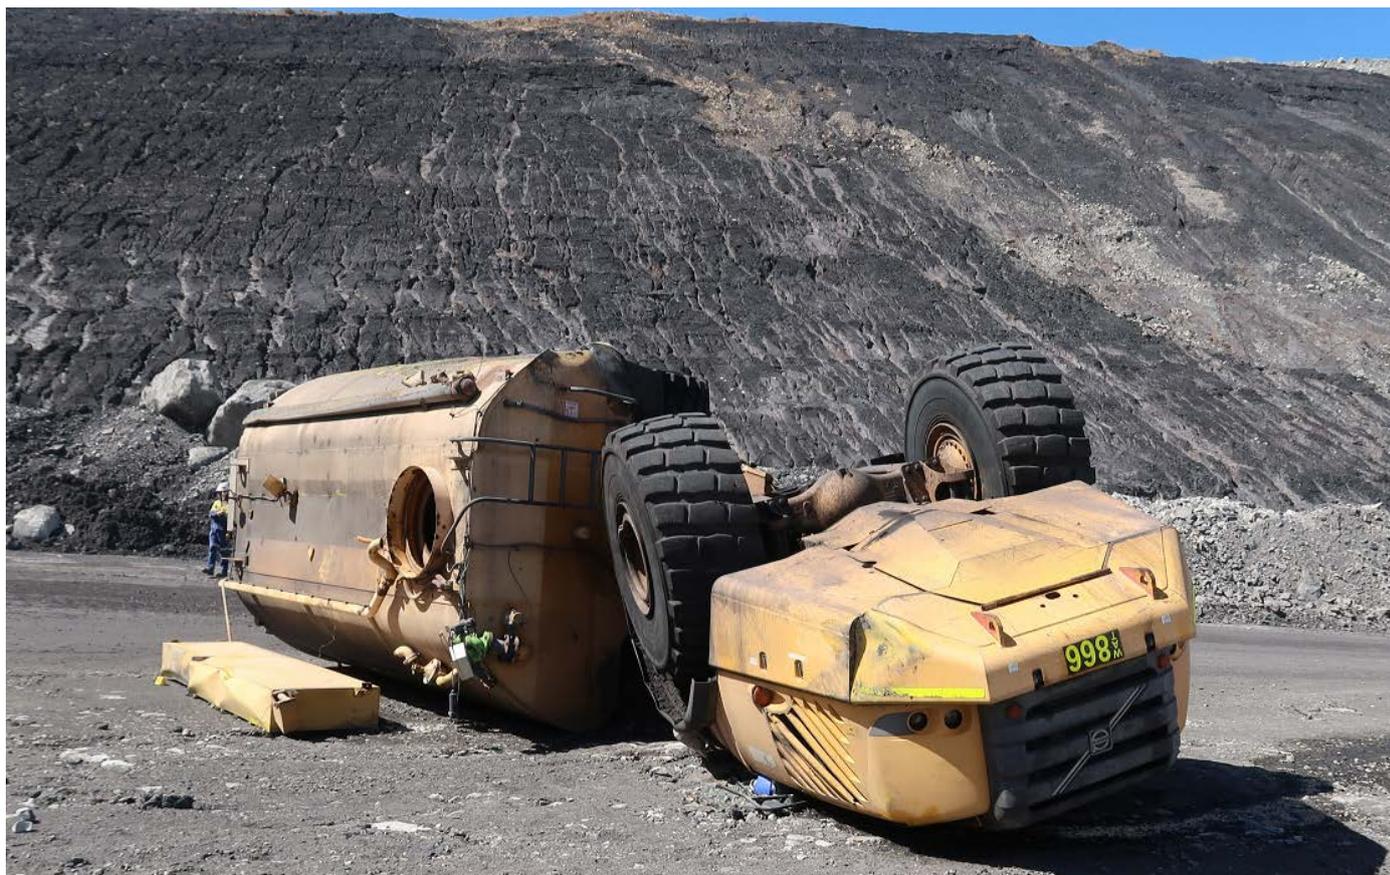
**Photograph 1: Final position of articulated water cart.**

The fully loaded water cart was then driven down the access ramp toward pit bottom to a right-hand bend. The water cart failed to negotiate the bend and rolled over with the cabin coming to rest on its roof.

Mine operators must have effective safety management systems in place and identify risks associated with the operation of mobile plant. All plant must be fit for purpose and safety critical systems and safety-related components must function as designed.

Safety critical systems include braking, steering, warning systems and interlocks. Safety-related components includes fixed components such as steering arms, and operator protective devices such as ROPS (roll-over protective structure) and FOPS (falling object protective structure).

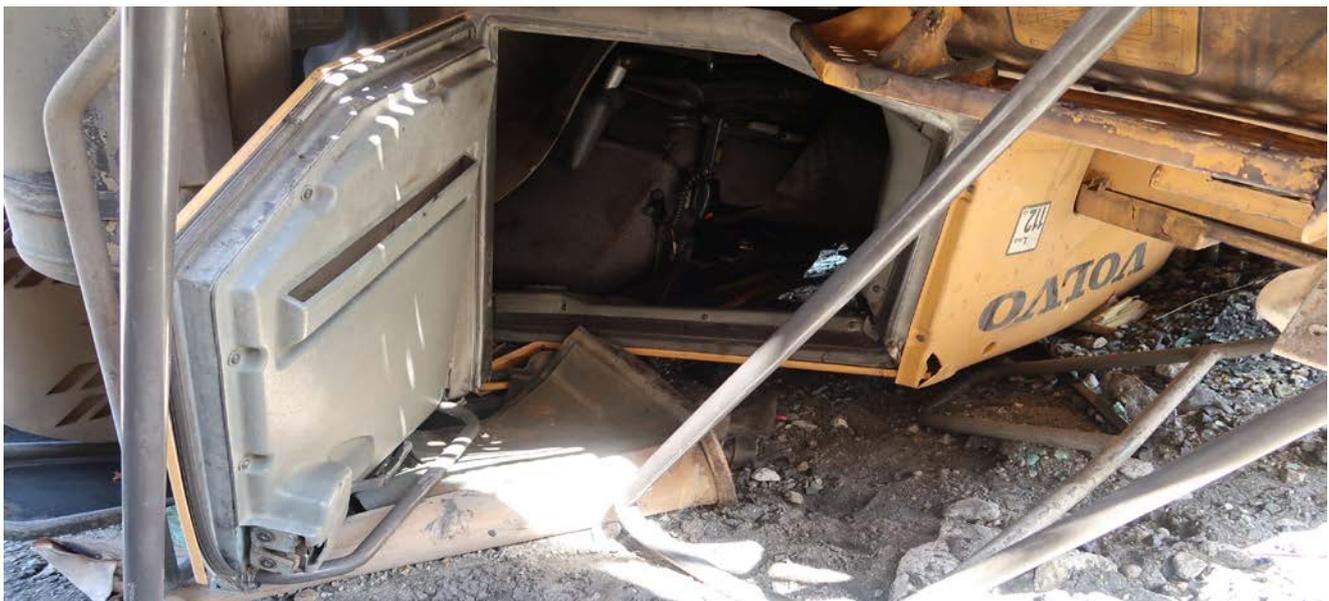
The worker managed to free himself from the damaged cabin of the water cart. The worker walked up the ramp where he located other workers. The worker suffered a large laceration to his lower back. The worker was transported to the workshop where first aid was rendered before he was transported to hospital for further treatment.

**Photograph 2: The damaged cabin of the articulated water cart.**
