DATE: APRIL 2018

Increase in shattered windscreens on mobile plant

This safety bulletin provides safety advice for the NSW mining industry.

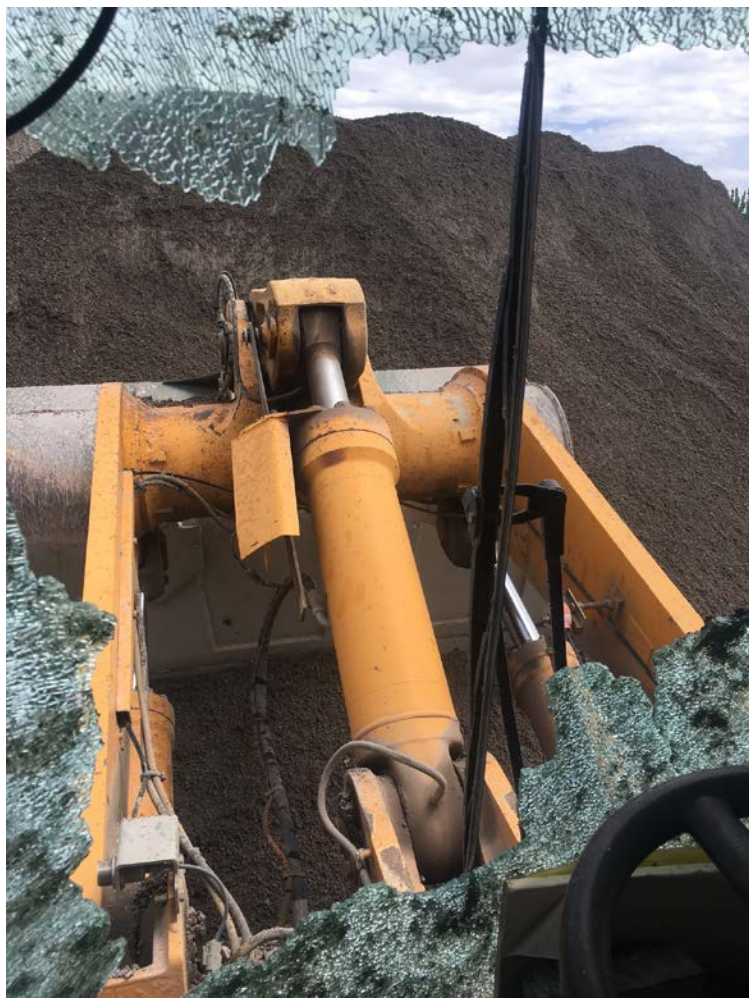
Figure 1: Rock in the loader bucket fell backwards rolling off the tilt cylinder into the cabin. (SinNot-2017/00529)

Incident 1: A front end loader was on the final product road base stockpile. The loader operator crowded the bucket forward to tip material out and then crowded back. When crowding back, a 20 mm rock struck the windscreen causing it to shatter. In this case the operator was not injured.

- install laminated glass as a minimum standard
- provide sufficient technical information of the glass (including various options) offered in the mobile plant for end users to consider as part of their risk assessment activities.
