## CIRCUMSTANCES

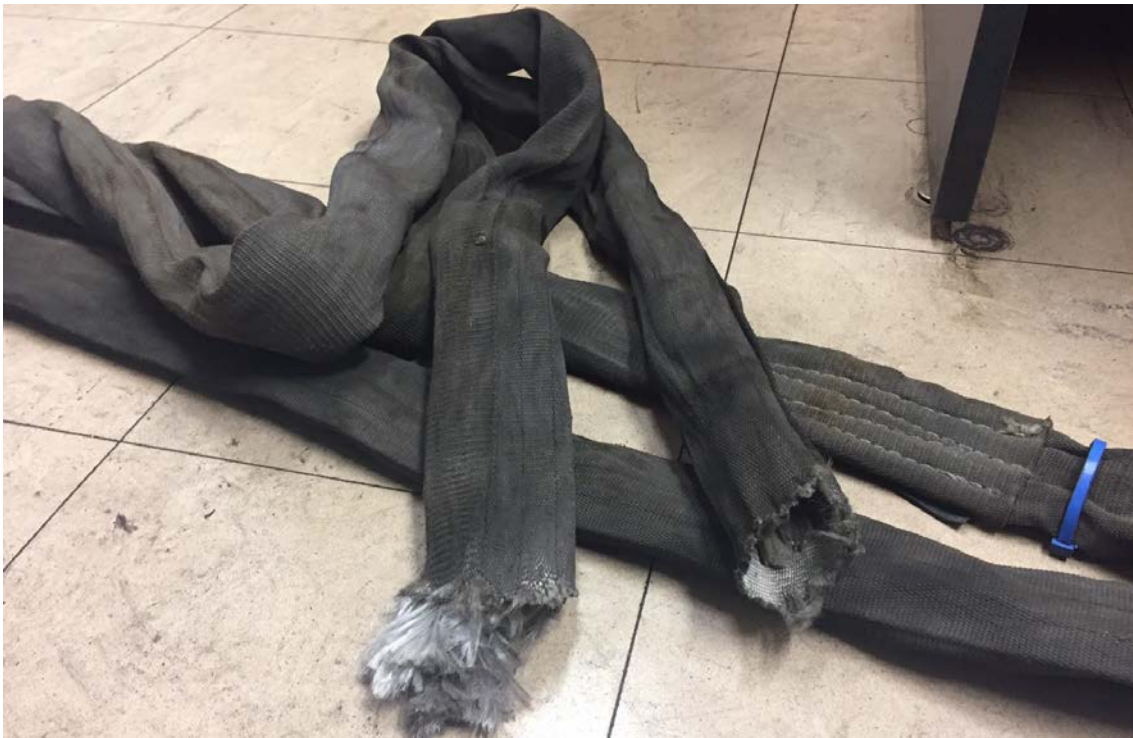
Figure 2: The failed sling

It appears that the slings had worn on the sharp edges of the flange and the bolts. The remaining sling, when removed, also had some cuts and abrasions through the outer casing and into the core.

When lifting any load using synthetic or soft slings, ensure that:

- there is no potential for the sling to be damaged during the lift, such as by sharp edges, squashing or other methods\*
- slings are inspected by a competent person for damage before each lift
- where possible, loads should be lifted with designated lift points. This should be considered during the fabrication of equipment.
- riggers and doggers who sling the load are competent and licensed for the lift
- where the load has sharp edges or components are attached to it (for example, cleats), chain or wire rope slings are used. Synthetic slings must not be used unless they are protected from these sharp edges.
- lift plans for crane operations contain information, including working load limit, for all items to be used for the lift
- sling selection considers the potential for damage to the sling from the load
- all 'drop' or 'fall' zones are clear and secured.
