Resources Safety and Health Newsflash

Manual fire suppression activation units.

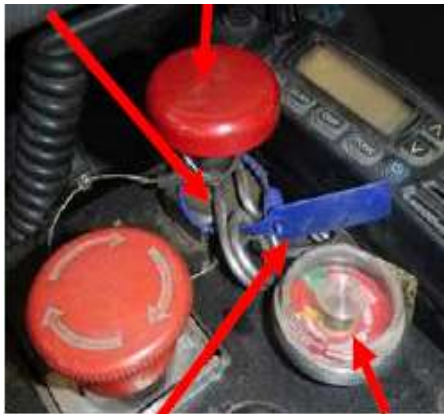
An incident occurred at an opencut coal mine where a CMW was unable to activate and remove a fire suppression safety pin during a fire event on a rear dump truck. This was due to an anti-tamper tag being fitted around the activation pin. At another mine, maintenance personnel discovered during an inspection the security / safety pin legs crossed over and not allowing the pin to be removed in an event of being activated.

Safety Pin Activation Button

Anti-tamper tag Charge Gauge

Mines inspect all Mobile Plant that have remote fire suppression units fitted with these type of manual pin and button actuators to ensure they fulfil the specific requirements in AS5062, which requires a 2 step action to prevent accidental discharge and make sure that:

- When anti temper tags are fitted, ensure they do not prevent security pin removal during an emergency.
- Security Pin legs are not crossed over.
- Review routine daily "Inspection Checklists" captures visual inspections of the on-board suppression units.

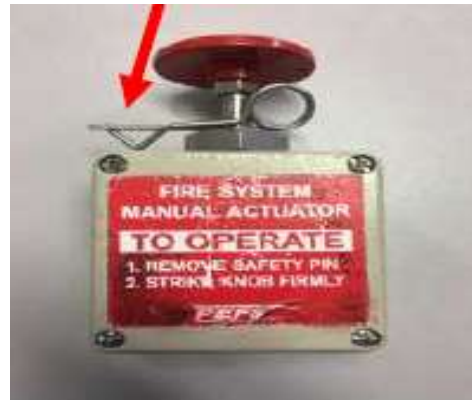
Security/Safety Pin Leg

Pin leg crossed over and cannot be removed
