Rock drill hits right leg

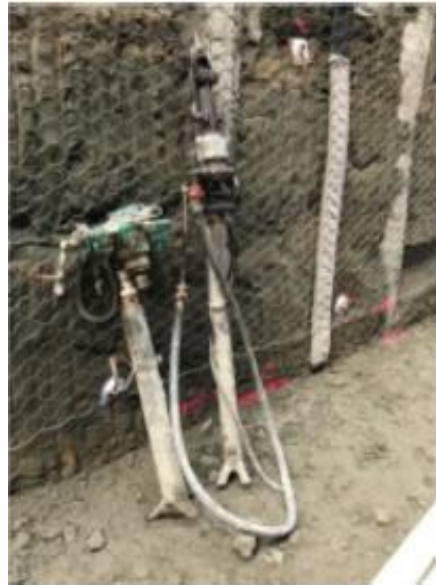
A worker was part of a three-man team, using an air leg drill. The worker was securing the BTE foot piece when he noticed the shoulder of the bench they were working on start to crumble. He shouted to the operator of the drill to stop and removed his foot from the foot piece. As he did this the drill leg bounced up and hit him on the side of his right leg, near his knee. The worker sustained a laceration to his leg and contusion to his knee.

The ground where they were working was soft and the area was very noisy, both of which contributed to the incident.

- **Where possible, use engineering controls to remove the person from the line of fire. In this case, the use of a drill ladder would have been an appropriate engineering control.**
- **Identify hazards associated with the work environment before setting up for any task. Ensure these hazards are adequately communicated to all in the work crew.**
- **Effective risk assessment/s are completed, and checked, prior to commencing any task.**
- **Supervise, and conduct physical checks, to ensure workers are completing the task/s in accordance with safe work procedures and/or risk assessments completed.**
