SAFETY ALERT

Transport Agency urging checks of truck drawbeams

The Transport Agency is investigating a catastrophic failure of a truck drawbeam that resulted in a laden heavy trailer separating on 18 October 2016.

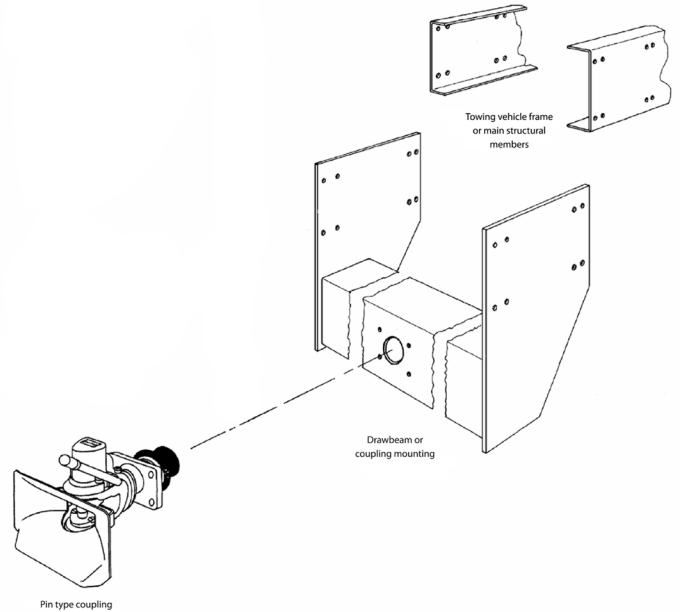
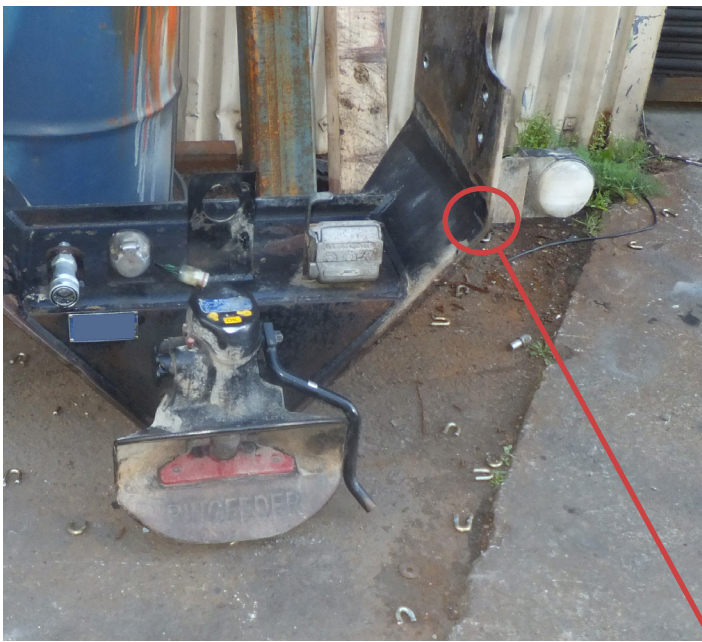
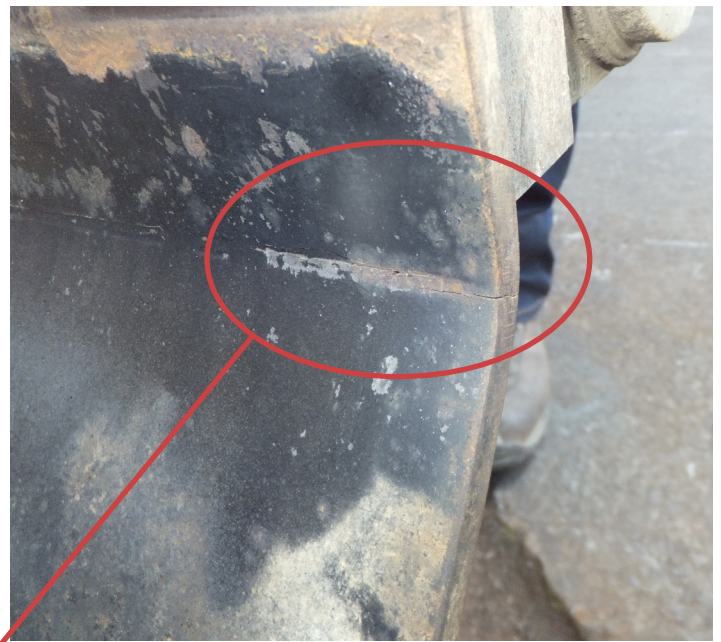
In the meantime, this safety alert is asking truck operators, service personnel and vehicle inspectors to check for signs of cracks in drawbeams as shown below.

Crack

Any findings of fatigue cracking requires immediate removal of the truck from trailer towing services and repair managed with a body builder and their heavy vehicle specialist certifier. Please report any drawbeams with signs of fatigue to vehicles@nzta.govt.nz with contact details, vehicle registration number and location of drawbeam or vehicle.
