## Significant Incident Report No. 259

**Subject:** Electrician injured by arc flash in low voltage switchboard

**Date:** 06 April 2018

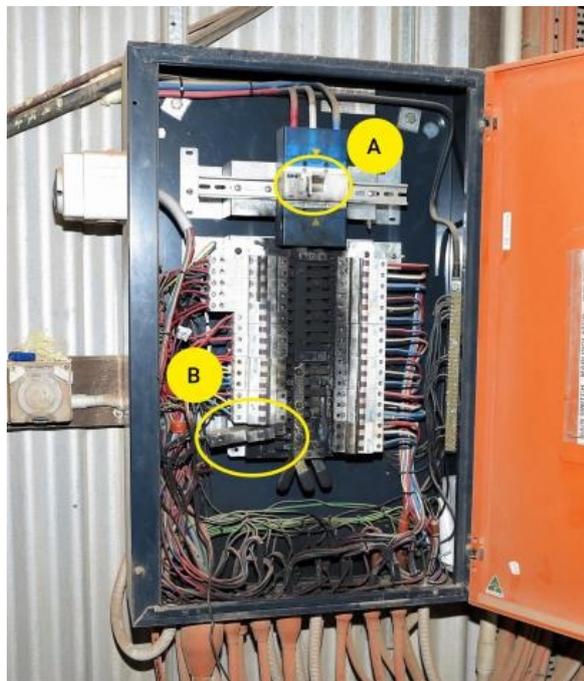
In February 2018, an electrician went to install a new power supply in a wall-mounted, low voltage (415 V) switchboard to provide three-phase power for an electric motor. He removed the escutcheon panel from the front of the switchboard (which was still live) and, as he tried to remove an existing circuit breaker with a screwdriver, there was an arc flash.

Arc flash damage to the low voltage switchboard showing the isolator in the "On" position (A) and the circuit breaker that was to be removed (B).

- There was a short circuit while working on the live switchboard.

- Electrical work was undertaken while the switchboard was live.
- An inadequate risk assessment was conducted before carrying out the live electrical work.
- There were inadequate fault protection devices upstream of the switchboard.
- Inadequate personal protective equipment (PPE) was worn.

When working on or near energised electrical equipment, the following actions are recommended to reduce the potential for electric shock and arc flash incidents:

- Before working on or near electrical installations, determine whether there is a requirement to work on the installation while energised.
- If a situation meets the conditions to work on or near energised electrical equipment or circuits, duty holders are to:
  - undertake a written risk assessment, performed by a competent person
  - develop a written safe work method statement
  - confirm suitable safety equipment and PPE are selected and used.

*Note: A risk assessment should include considering existing fault protection upstream of the electrical installation to be worked on.*

- If required to de-energise the electrical installation, develop an appropriate procedure for de-energising the electrical equipment or circuits to be worked on.
