Tipper ram breaks hitting truck cabin

24 May 2018

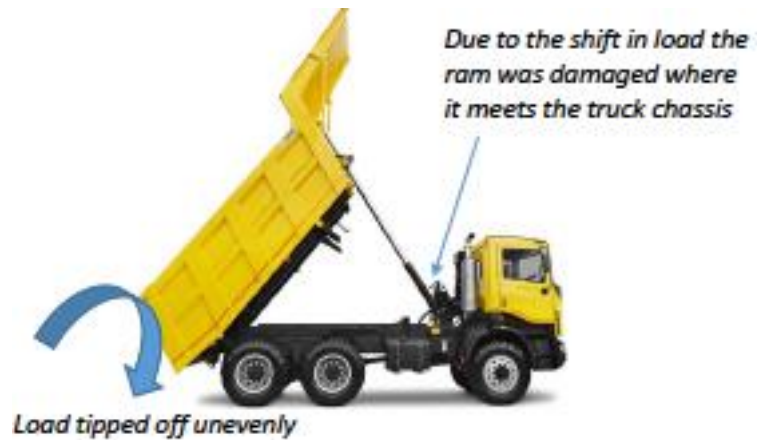
A sub-contractor was tipping a load of waste product from recent storm damaged roads, when the load shifted putting extreme pressure on the single lift ram. The ram broke and hit the truck cabin, smashing the rear window. No-one was hurt in the incident.

Contributing factors in the incident were:

- The load was a mixture of clay and road metals being cleaned up following recent storm damage.
- The hazard of material hanging up had been identified and an excavator was positioned next to the tipper to assist with discharging the load. This may have helped the truck not tipping on its side.
- A shortage of equipment on site led to inappropriate trucks being used to cart waste material.

- **Fit-for-purpose equipment and plant is used for any task.**
- **Loads are tipped on flat, well compacted ground at all times.**
- **Maintenance procedures ensure that hydraulic rams and mounting points are regularly checked for damage or wear.**
- **Effective risk assessment/s are completed, and checked, prior to commencing any task. Adequate controls are put in place to tipping hazards and risks.**
- **You supervise, and conduct physical checks, to ensure workers are completing the task/s in accordance with safe work procedures and/or risk assessments completed.**
