Worker injured clearing blockage in crusher

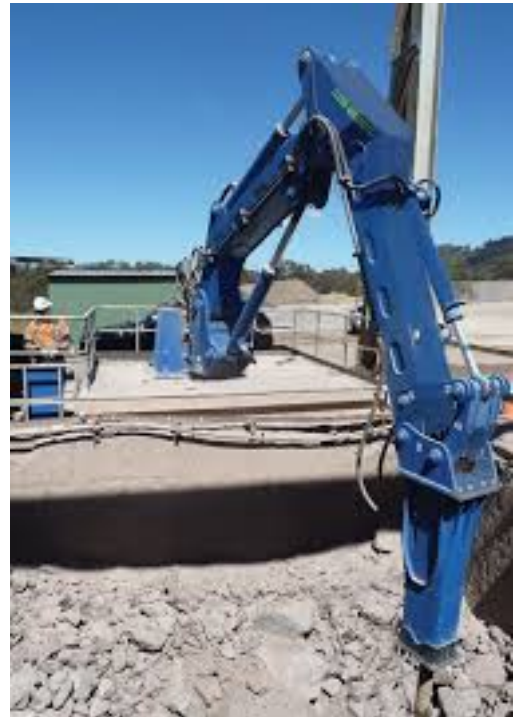
- **A fixed breaker (as in the photo above) or rock breaker attachment on an excavator are used to clear blockages while the crusher is running. NO PERSON should be working in or around any crusher while it is running.**
- **Procedures for clearing blockages in crushers are clearly understood by all workers at site. This should include training and assessment of competence to work on crushers.**
- **Activities are adequately supervised, and tasks observed, to ensure risk controls are in place and are effective.**

DO NOT attempt to clear blockages by barring the blockage while the crusher is operating, or entering the crusher chamber pit to manually remove the cause of the blockage/bridging material.
