NZ Safety Alert

November 2019

Worker fall from conveyor frame

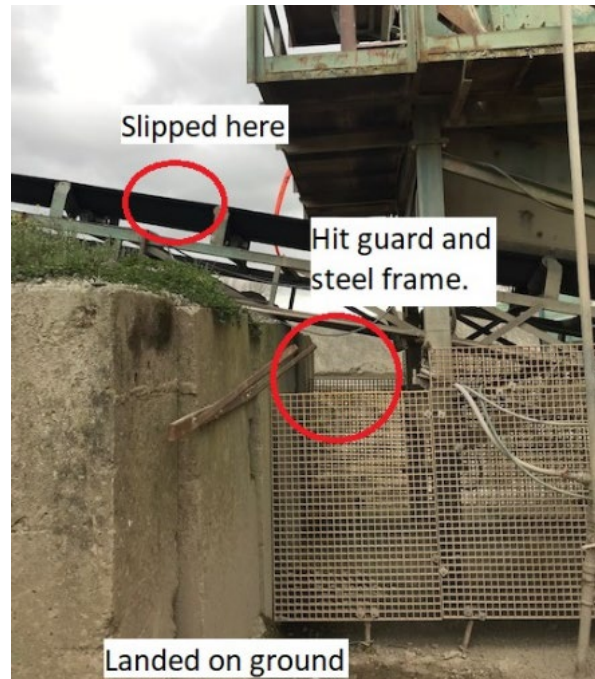
While performing a screen change, a worker slipped from a conveyor frame falling approximately 2m making contact with guarding and a steel frame (used for hanging hoses) during the fall. The employee sustained a fractured rib and bruising. First aid was applied, and employee taken to A&E for assessment.

The work method for the screen change had been used for a number of years. A fall from height risk had not previously been identified.

1. Fall hazards such as trip hazards and areas where workers can fall from height are identified in risk assessments.
2. Adequate and effective controls are in place to ensure no-one is exposed to the fall hazards identified.
3. Any requirement to leave established access ways or platforms (including crossing handrails or any other barriers) to perform maintenance or any other activities, are risk assessed.
4. All activities are adequately supervised, including workplace inspections and task observations.
