NZ Safety Alert

Worker injured using grinder

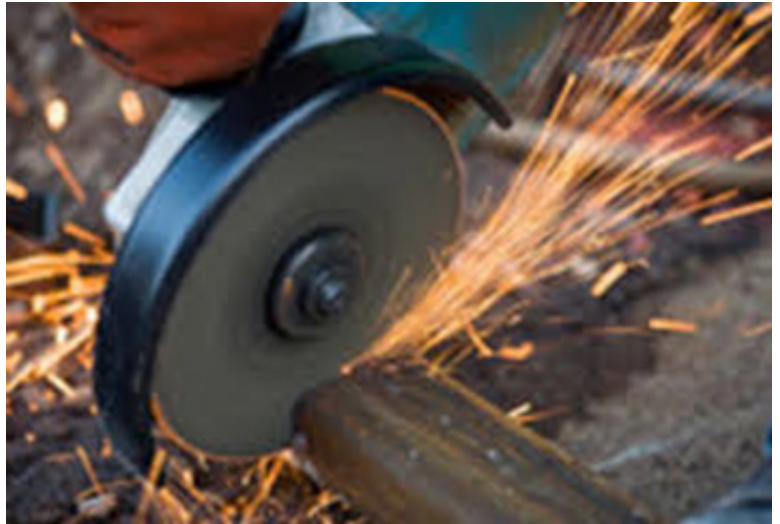
A worker was using a grinder on the edge of a steel bar when the grinder kicked back at him. His overalls became entangled with the tool around waist height. This caused a tiny abrasion to his stomach area. First Aid treatment was applied. No further medical assistance was required.

Handheld grinders present many hazards including:

- Entanglement with turning wheel or disk
- Projectiles from incorrectly used wheels or disks
- Projectiles from damaged disks
- Contact with an uncontrolled grinder
- Electrical current

It is essential that grinders are used as designed, with appropriate wheels and/or disks.

1. Operators are trained and assessed as competent to operate handheld equipment including grinders.
2. When using handheld tools, operators wear tight fitting clothes without loose or dangling items to avoid the risk of entanglement.
3. You always use wheels and/or as per the Original Equipment Manufacturers specifications.
4. Hand tools are always operated with appropriate guards in place and with the use of suitable Personal Protective Equipment.
5. Regular workplace inspections are conducted to identify damaged or worn tools and attachments.
6. You regularly inspect and test grinders
