NZ Safety Alert

Fall of ground damages excavator

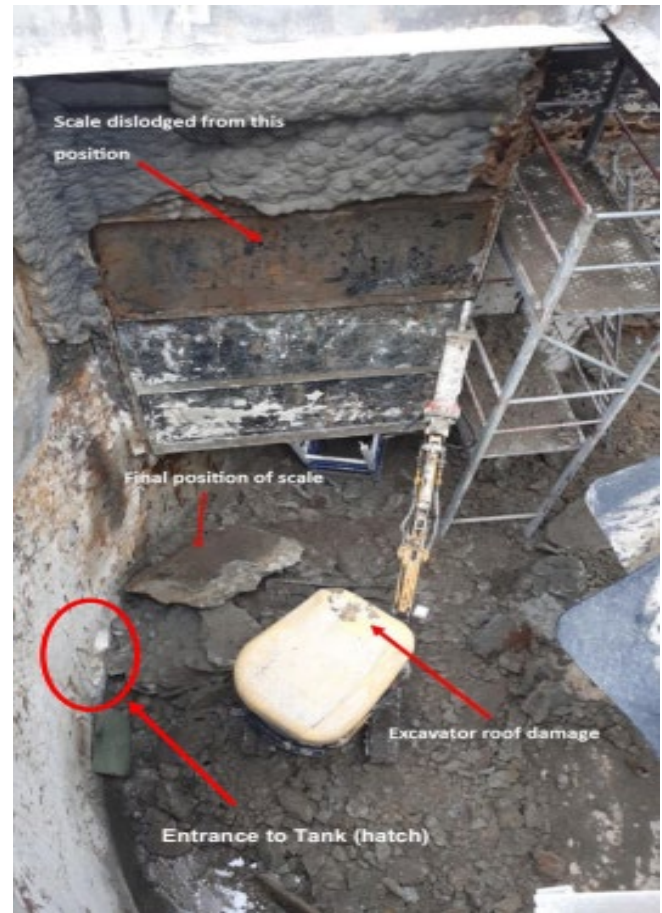
While descaling a tank, a 1.8 tonne open cab excavator fitted with FOP (falling object projection) dislodged a 1 metre section of scale from the wall.

The piece of scale slid down the boom before impacting the left-hand corner of the excavator cabin roof and the guard rail. A smaller section of scale broke off and came to rest on the outside of the entry hatch.

There were no injuries sustained by the excavator operator.

1. You review cleaning and scaling procedures to ensure workers are not exposed to fall hazards.
2. All workers are trained and regularly assessed as competent in cleaning and scaling procedures.
3. All activities are adequately supervised, including workplace inspections and task observations.
