Safety Alert

Chain recoil causes fatal injuries

The purpose of this Safety Alert is to highlight the risk of serious injury or death when using chains in towing or recovery operations.

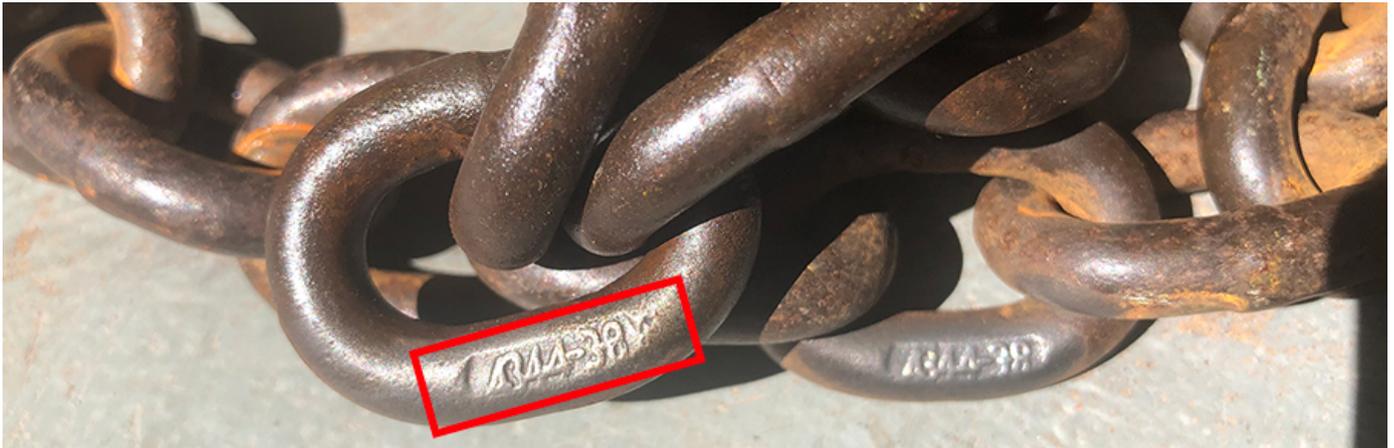
Image 1: The 4344-38 identification marking on this chain means it complies with Australian Standard 4344 and has a 3.8 tonne capacity.

- Consider the use of recovery tow stops instead of chains when recovering any vehicle/equipment.
- If you choose to use chains (including accessories such as hooks and shackles), determine what you can use the equipment for by checking for any identification markings and referring to the manufacturers product guide.

- The manufacturer's information will provide the safe working load limit (WLL) of the chain and accessories, and if the equipment is suitable for how you want to use it.

- The identification markings indicate a chain complies with the mechanical properties and testing requirements for a specific Australian Standard.
- Make sure the weight of the object you are towing is within the WLL of the chain used.

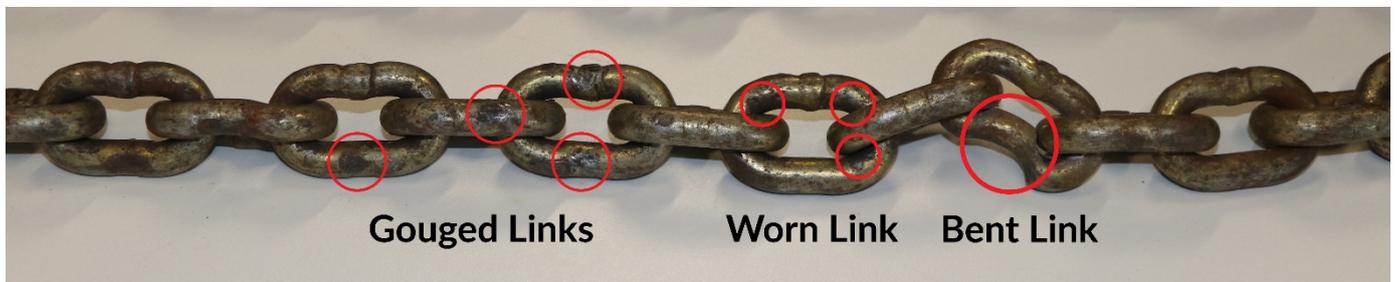
- A risk assessment was not completed and safe work procedure were not developed for the recovery of the broken down excavator.
- The chain used may not have been suitable for towing.
- Some links in the chain showed signs of wear and damage.
- The quick clamp on the excavator, where the chain was attached, was raised at the height of the cabin.
- The excavator had previously been vandalised and the cabin glass was missing.

Image 2: A section of chain, with examples of wear and damage.

- Inspect the chains before use for signs of damage or wear. Do not use chains with damaged links.
- Refer to the excavator's operating manual for appropriate attachment points for towing; avoid attachment points, which are in line with the cabin or the operator.
