Reference: SB-0120.00 Safety Bulletin Carnell Hydraulic Lock Lost Time Injury

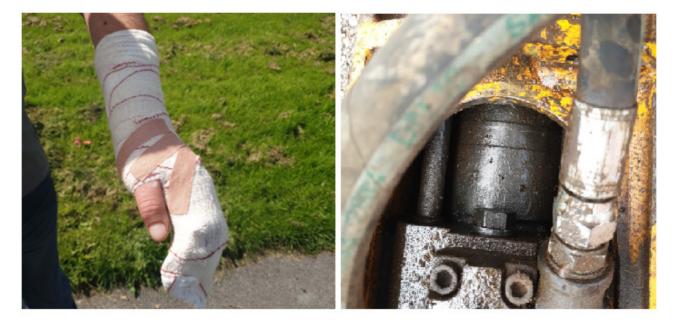
A Carnell employee sustained an open fracture to his index finger and lacerations to his middle finger when he removed a bolt within an excavator breaker attachment. The injured party (IP) received 5 stiches and underwent minor surgery under a local anaesthetic to 'pin' the open fracture. Fortunately, the employee is expected to make a full recovery and was able to return to work 2 days after the incident occurred.

The employee sustained the injuries as he attempted to relieve excess hydraulic pressure known as 'Hydraulic Lock' which prevents the hydraulic hoses being attached to the excavator couplings. This can occur when any hydraulic attachment is:

The IP, without any training, attempted to remove the hydraulic lock himself by loosening the nuts at the hydraulic coupling. When this did not work the IP contacted the plant supplier to arrange for a plant fitter to attend site. Whilst waiting for the plant fitter the IP identified a bolt within the body of the breaker attachment and, without any knowledge or experience, loosened the bolt until it ejected at speed into his fingers.
