# WEEKLY INCIDENT SUMMARY

Week ending Friday 22 November 2019

This incident summary provides information on reportable incidents and safety advice for the NSW mining industry. To report an incident to the NSW Resources Regulator: phone 1300 814 609 24 hours a day, 7 days a week.

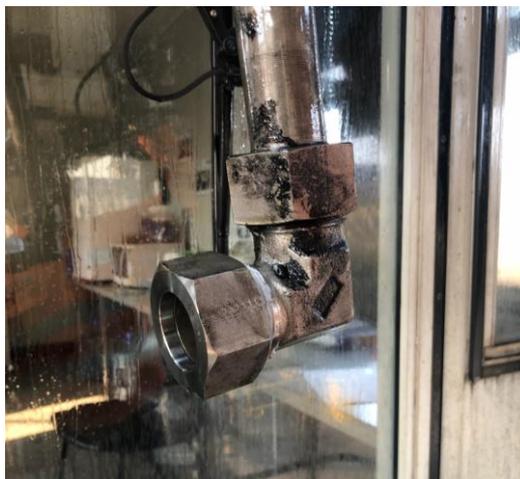
Dangerous incident  
IncNot0036113

A worker was sprayed with oil from a failed hydraulic fitting.  
A stainless steel hydraulic pipe had been replaced on a train loader and was undergoing pressure testing when a new fitting on the pipe failed and released fluid that sprayed onto the worker. The worker was cleared of fluid injection injuries.

An escape of pressurised fluid in the workplace represents a failure of a risk control to a major hazard (pressurised fluids) that may cause a serious or fatal injury.

Mine operators are reminded that when equipment is being tested after maintenance and repairs, effective no standing zones are to be put in place that removes workers from the line of fire if a failure was to occur.
