SAFETY ALERT

DATE: February 2021

Unattended haul truck rolls 65 metres

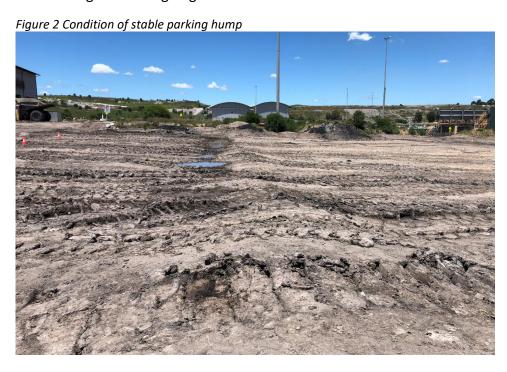
Further investigation on the vehicle found that a solenoid on one of the park brake valves failed and the air pressure did not bleed from the park brake circuit. This resulted in the park brake not being engaged automatically. The remainder of the fleet onsite was inspected and the same fault was also identified on another vehicle.

- All mobile plant park-up areas are designed, constructed and maintained to enable safe and stable parking.
- Work area inspections verify that mobile plant park-up areas are constructed and maintained to the standard.
- Brake testing regimes on mobile plant includes testing fail-safe mechanisms and interlocks.
