# Underground conveyor equipment incident puts workers at risk

Causal investigation

Title: Causal investigation: Underground conveyor incident puts workers at risk

First published: December 2017

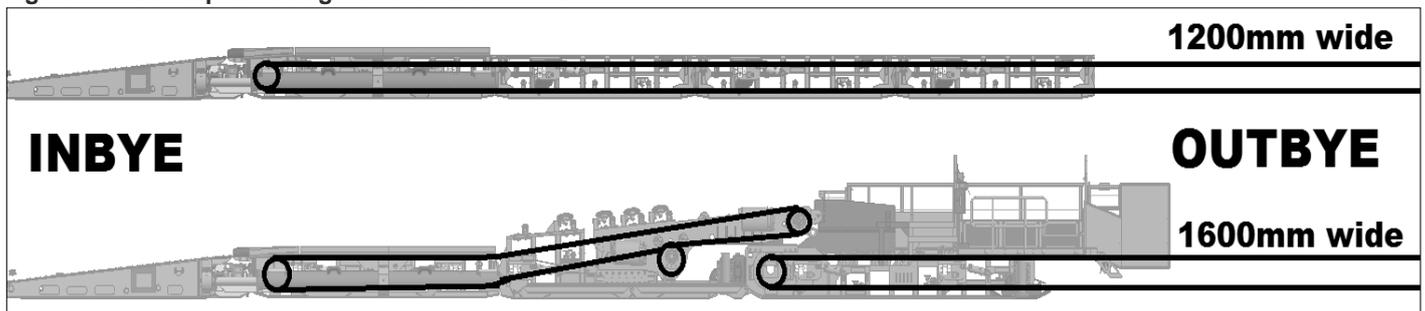
Figure 11 - Conceptual design differences in DMU.

In place change mining installations, the panel belt runs into the DMU and the tail roller for the panel belt is actually at the inbye end of the DMU, and as such there is no tail end unit as there is in the Ulan West design. The panel belt width is typically 1200 mm or less. Refer to figure 5.

As the panel belts at Ulan West are required to carry longwall production at 5000TPH, the gate belt width was set at 1600 mm. As a 1600 mm belt would not fit into the standard DMU frame, Joy Global designed the DMU with its own belt drive. The frames could have been widened to accept the 1600 mm belt but this increase in frame size would have reduced clearances and walkways around the machine. Refer to figure 5.

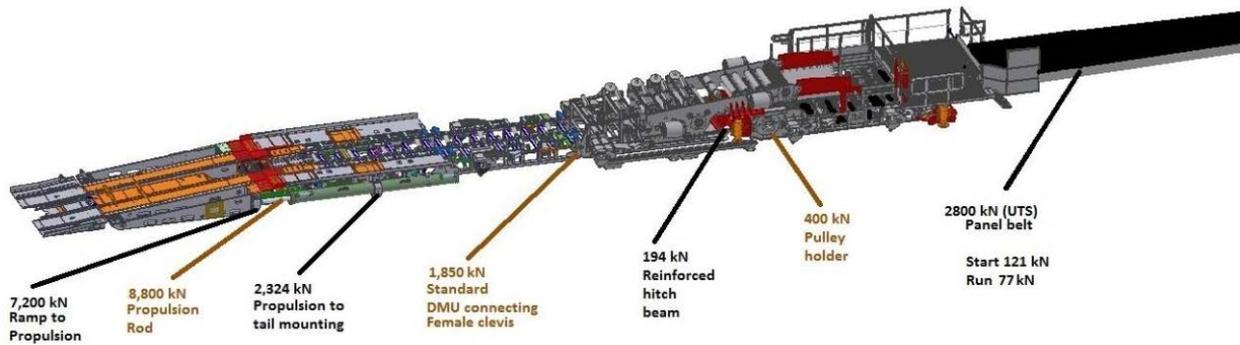
Figure 15: DMU system minimum yield loads structures/connections

The following DMU components are labelled with the minimum yield loads for that structure / connection in the DMU system.

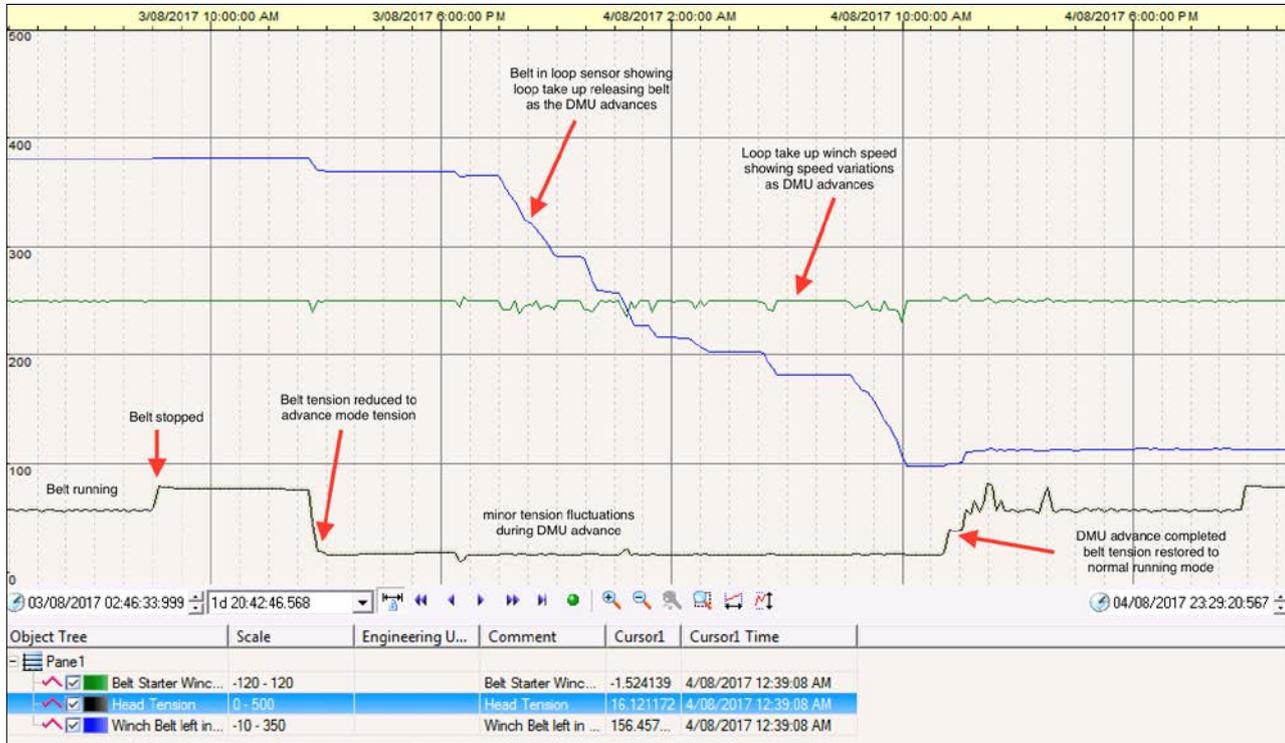
Figure 18: On 3 August 2017 the DMU was advanced as normal without issue.

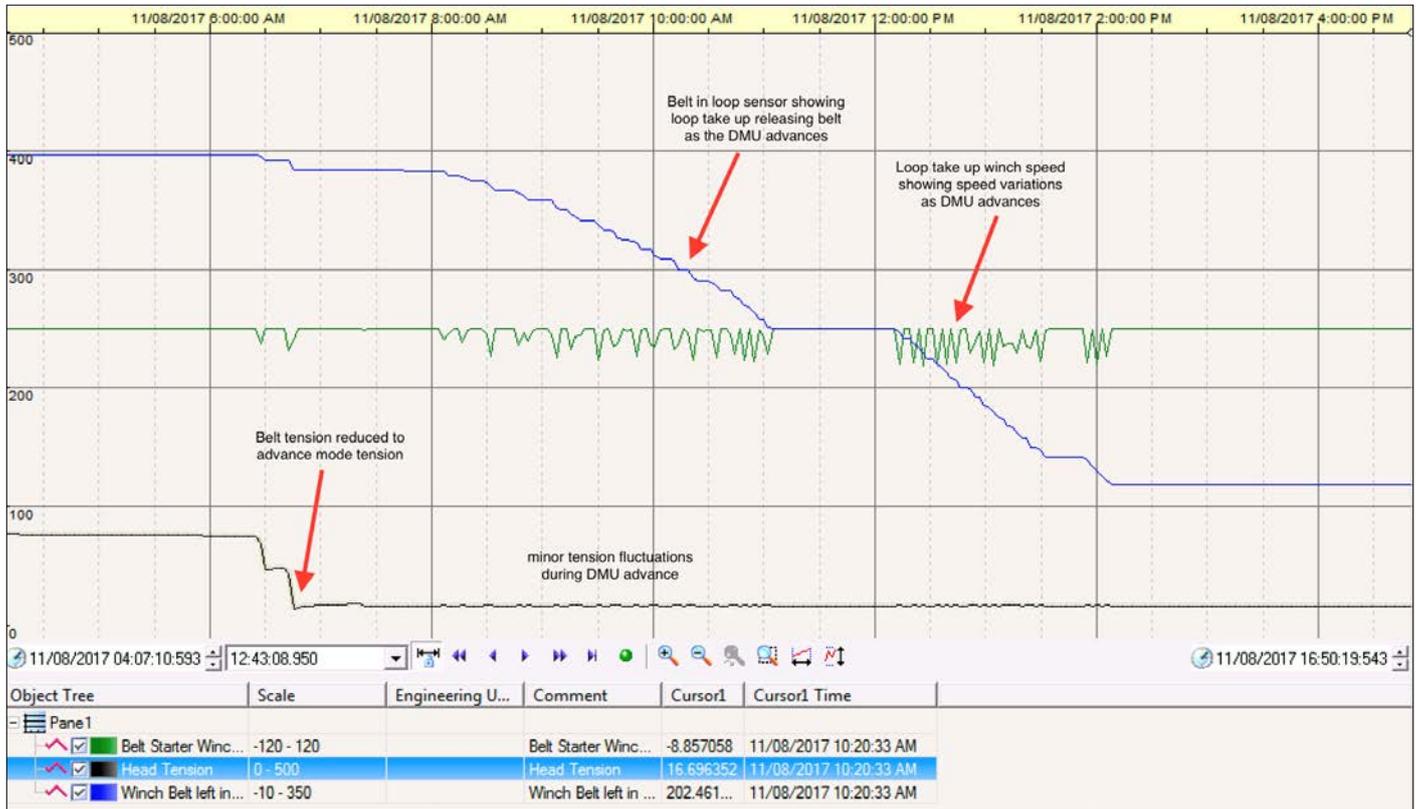
On 11 August 2017 a hazard form was completed and submitted by a supervisor in response to the reports from 20 July 2017 that the DMU was allowed to advance when the winch was faulty. Further testing was undertaken with two actions identified. The testing was completed before the hazard form was completed. The main purpose of completing the hazard form was to capture this incident and that the two actions could be tracked.

Figure 19: On 11 August the DMU advanced as normal without issue.

Action – Review belt move procedure and add step to check belt tension via BMA voice or control room if not confirmed. Each DMU move up - consult development crews. Completed 21 August 2017. Procedure update to version 14.

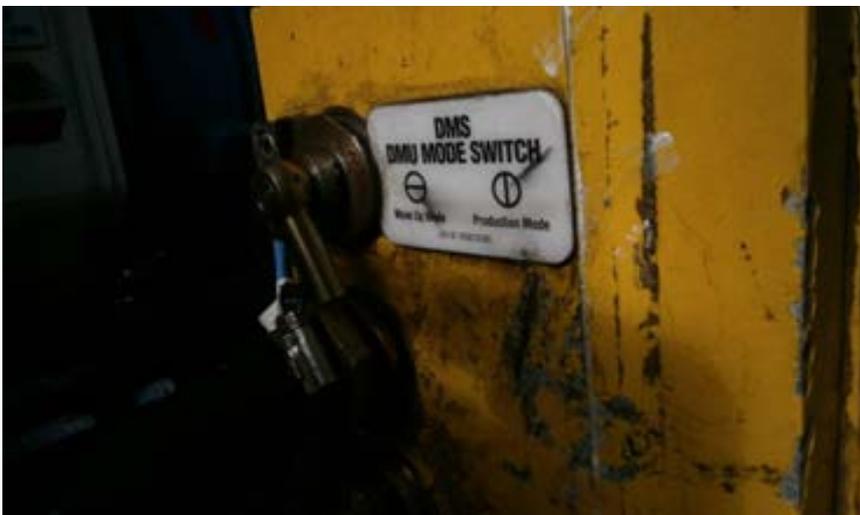
Figure 22 - Mode switch from procedure.

The outbye mode is not used at Ulan West Operations with the DMU as the Ulan West Operations DMU cannot tram outbye by design.

The mode selector switch was to be placed in move-up mode (inbye) to enable belt advance (move-up). The switch was observed in the vertical position (figure 8) (production mode) on enclosure 5 on the DMU ramp area on the inbye end of the DMU. “DMS – DMU mode switch” was tested following this incident, identifying that this switch and the switch activation was firm, confirming the switch would remain in position following selection of mode.

During testing, it was identified that the switch position and switch position labels do not align. This is shown in figure 8 where the switch is in move-up mode.

Figure 7 is included within the site belt extension safe work procedure using DMU [ULW MIN PRO 0365, V15] which indicates the correct switch position corrected using additional markings.

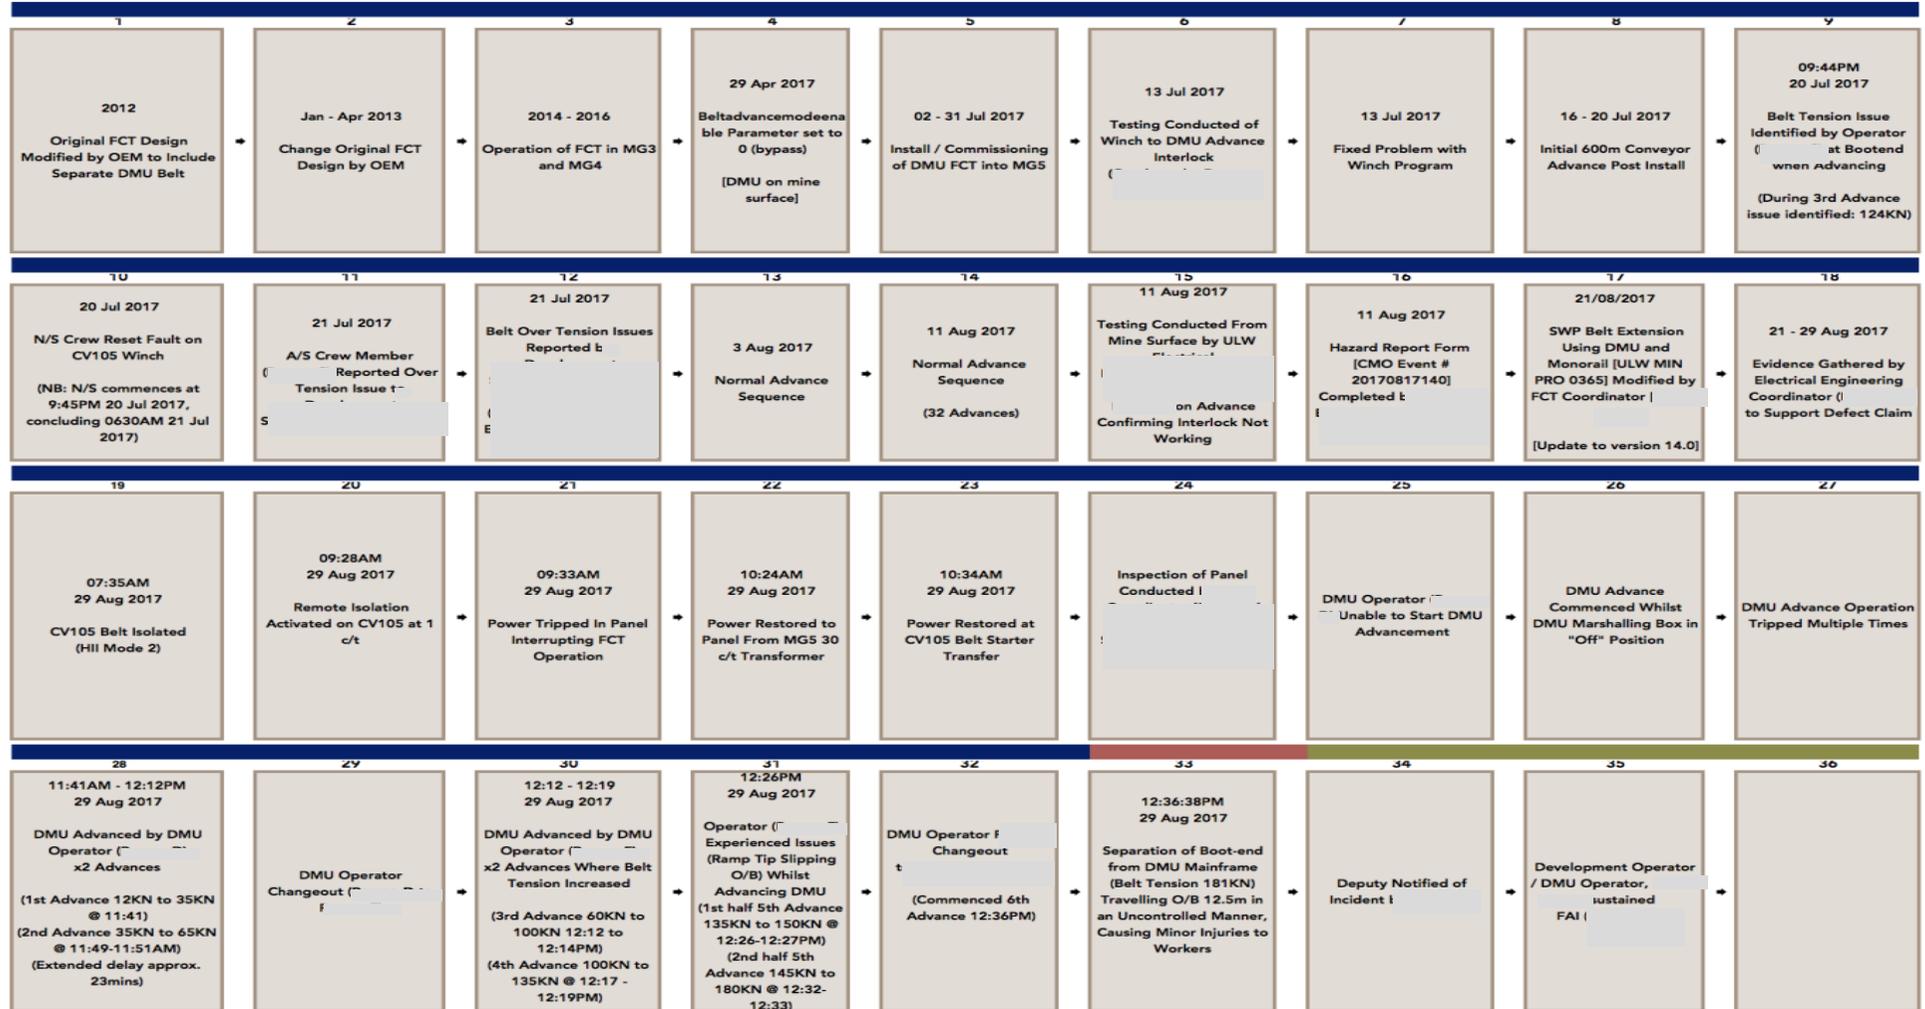
## A.1 ICAM timeline

Underground DMU boot-end separated from mainframe
