# **Guidance Note QGN 29**

## **Surface tailing storage facility management**

*Mining and Quarrying Safety and Health Act 1999*

**December 2017**

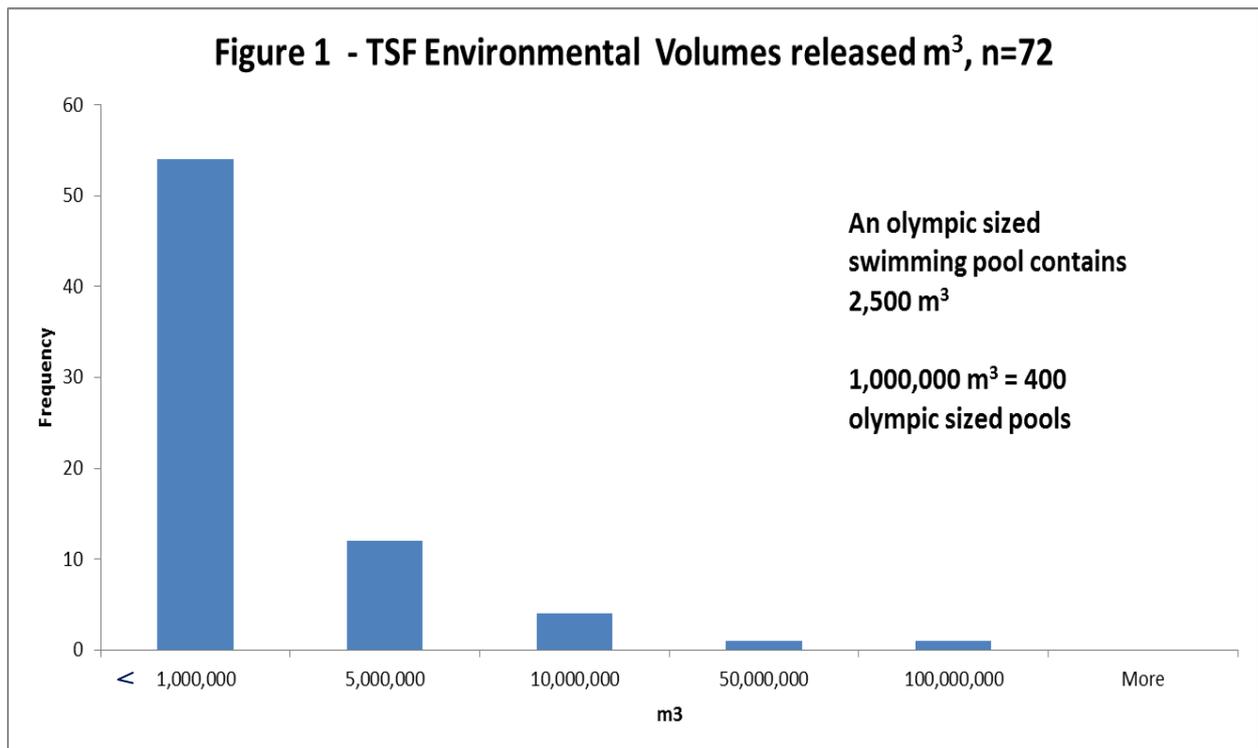
Figure 1 below graphs the magnitude of releases from 72 tailings dam failures.

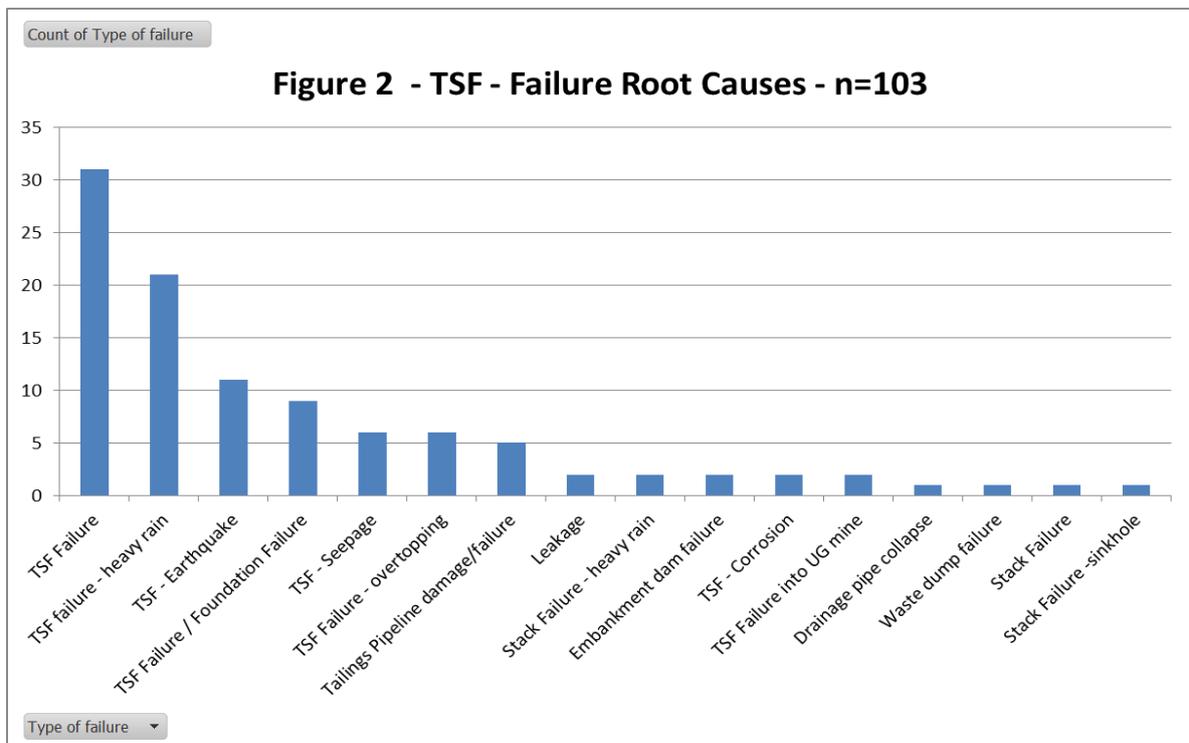
Figure 2 below provides a frequency analysis of historical TSF failures and their root causes<sup>1</sup>.
