Week ending 5 September 2018

This incident summary provides information on reportable incidents and safety advice for the NSW mining industry. To report an incident to the NSW Resources Regulator: phone 1300 814 609 24 hours a day, 7 days a week.

High level summary of emerging trends and our recommendations to operators.

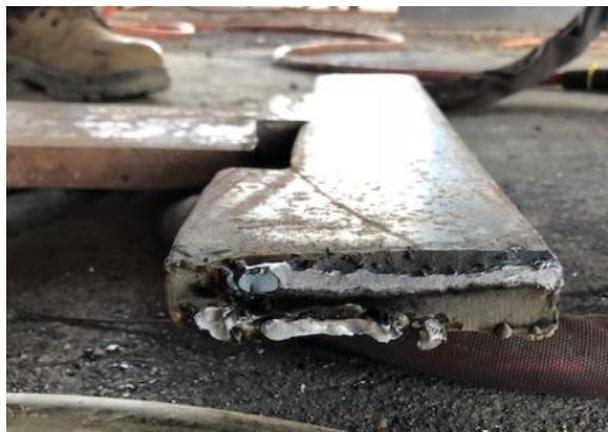
Incident type	Summary	Recommendations to industry
Dangerous incident SinNot-2018/01427	Damage to an 11kV cable was identified during a routine inspection. The outer sheath was damaged when it was hit by an item of mobile plant. The contact was not reported at the time it occurred.	Mine workers are reminded of their duty under section 28 of the WHS Act 2011 to take reasonable care that their acts or omissions do not adversely affect the health and safety of others. When hazards or incidents are not reported this can lead to people being exposed to health and safety risks.
Serious injury SinNot-2018/01414	A boilermaker suffered a fractured finger and lacerations when a strong back failed while repairing a dump truck body. The strong back was being used to support a portable hydraulic cylinder to enable repairs.	Temporary items used to support and hold loads must be designed and engineered to prevent injury to workers during their use.
