Safety Flash 16/19

1 LTI: Foot Injury After Standing on Rotating Winch Drum

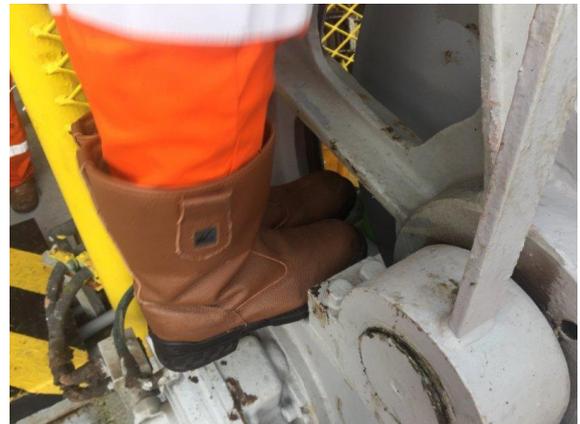
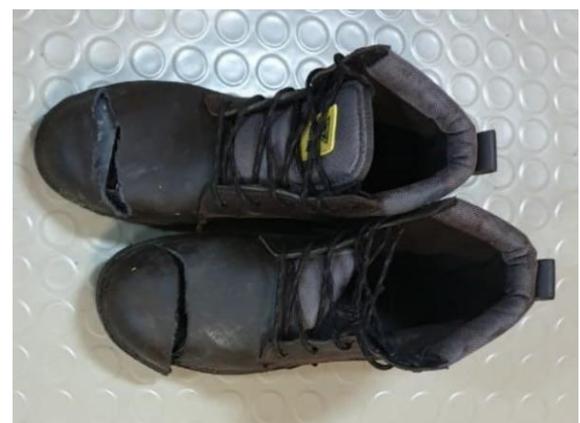
An AB was taking part in a task to re-spool a wire onto an aft deck tugger winch, when he climbed onto the side of the tugger winch and, whilst stood there, the rotating winch drum trapped both his feet. His injuries include a fractured foot and severe abrasions.

- ◆ The crewman failed to identify the hazards associated with the tugger winch;
- ◆ None of his colleagues intervened or told him to stop when they might easily have **STOPPED** the job' when he put himself in the line of fire;
- ◆ The risk assessment was inadequate – it did not include this particular hazard associated with the tugger winch.

- ◆ "Hazard hunt" focusing on winches and the hazards associated with them;
- ◆ Review of risk assessments related to deck operations to ensure that the hazards associated with winches are captured;
- ◆ Someone was injured because no-one intervened or stopped the job; remind all that it's OK to **STOP** the job if it's unsafe.
