Man falls inside crusher machine

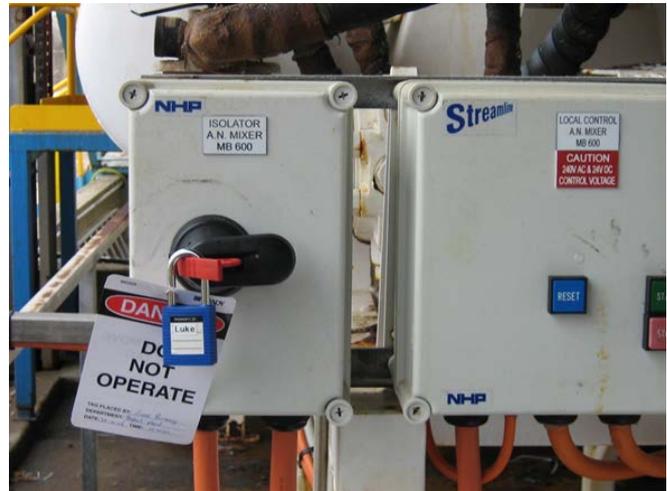
A quarry worker in the lower North Island was seriously injured when an impact crusher was “accidentally” started while the worker was welding inside the crusher.

Another worker had been asked to rotate the drum but pushed the wrong button and started the crusher. The worker fell into the crusher suffering serious injuries that required surgery and significant time off work.

We recommend that all sites review maintenance and isolation procedures and practices. You need to ensure that:

- **All plant is isolated prior to commencing any maintenance on that plant**
- **Isolation procedures are reviewed to ensure they include the use of clearly identified locks and that once isolated a “test for dead” is conducted to ensure there is no energy to the plant**
- **Locking pins or locking bars are used, if provided, to lock horizontal shaft rotors so that they will not spin when being worked on**
- **Crusher are maintained in accordance with original equipment manufacturers (OEM) requirements**
- **All workers are trained, and regularly re-trained, in site isolation procedures**
- **Regular workplace inspections are conducted to ensure that risk controls are in place and are effective.**
