Equipment Alert – November 4, 2011

2nd Update on Failure of High Pressure Gas Fittings and Valves in Refuge Alternatives

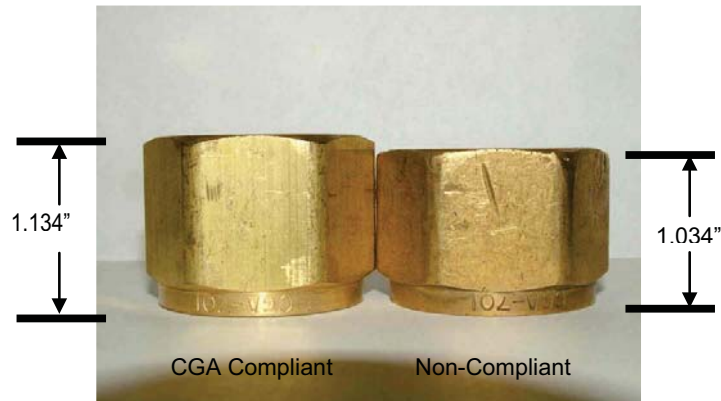
Following the January 9, 2011, failure, MSHA issued the Equipment Alert regarding a catastrophic failure that occurred in an oxygen cylinder fitting in an A. L. Lee refuge alternative in an underground coal mine ([Click here to view January 25, 2011, Alert](#)). The investigation revealed that the failed fitting did not meet the dimensional specifications of the applicable Compressed Gas Association (CGA) standard. (See Figure 1)

Figure 1 Measured length (shown upright) on CGA compliant and non-compliant high pressure oxygen fitting (nut)

1. All refuge alternatives should be physically examined to ensure correct fittings are installed on compressed gas systems. Operators were advised to contact the refuge alternative manufacturer to assist in the examinations. Additionally the operator was advised to ensure that the refuge alternative manufacturer performs all necessary repairs to the refuge alternative. The examination was to include removing access doors, if necessary, to measure and examine each fitting to verify compliance with the applicable CGA standard. The examination may have required removal of fittings to take necessary

measurements. A fitting identified with a CGA standard number does not guarantee that the fitting complies with the CGA standard. MSHA advised that the fittings should be physically examined to verify compliance.

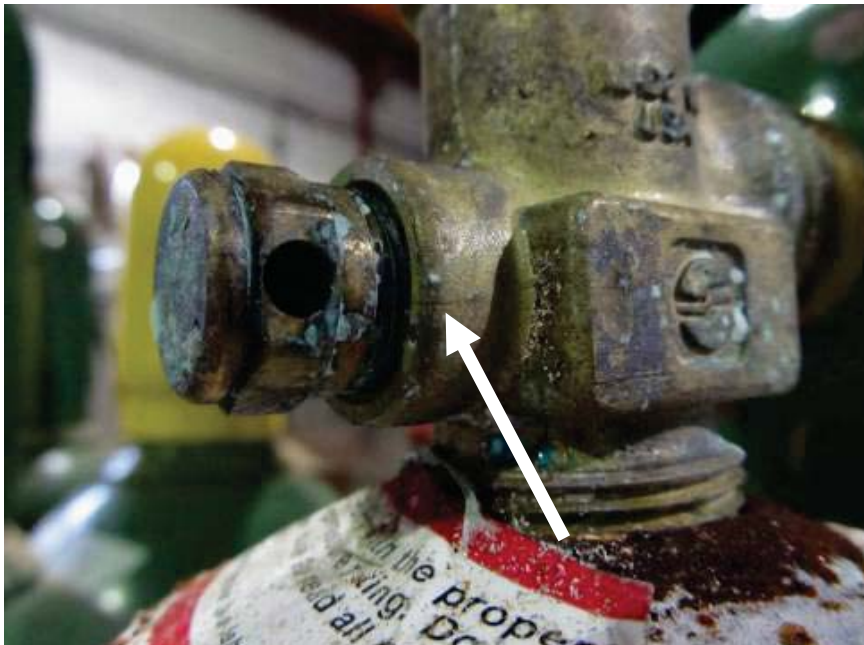
Following the second reported failure of a refuge alternative fitting ([Click here to view updated alert of February 10, 2011](#)) MSHA issued an updated Equipment Alert. This fitting met the dimensional specifications of the CGA standard. On February 3, 2011, A. L. Lee reported that cracks had been discovered in both the brass fittings and cylinder valves of a third refuge alternative that had been returned to their shop. (See Figure 2) These fittings also met the dimensional specifications of the CGA standard. These fitting failures demonstrated that the problem extended beyond dimensionally incorrect fittings.

In an effort to determine the mode of failure and possible causes, MSHA sent representative samples to the OSHA Salt Lake City Technical Center (SLTC) laboratory in Salt Lake City, UT. Quoting from the OSHA report, “The analysis performed at the SLTC revealed that the cracks are a result of stress-corrosion cracking (SCC) and the evidence suggests that dezincification is a contributing factor. The stress-corrosion cracks that have formed in the fittings and valves indicate that they are on the path to failure. The demonstrated short and unpredictable service life of the CGA brass valves and fittings is troublesome. The current situation left unchecked represents a safety hazard.”

Figure 2 – View of cracked cylinder valve. Arrow points to crack.

As part of the updated Equipment Alert of February 10, 2011, MSHA again recommended that mine operators contact their refuge alternative manufacturers and request that the manufacturers conduct a prompt and thorough examination of their units for interior and exterior cracks on fittings and cylinder valves. MSHA advised that, if this examination identified any fittings or valves exhibiting cracking, the refuge alternative should be removed from service until it can be repaired or replaced. These steps are necessary to assure that all refuge alternatives can be safely used in underground coal mines.

Based on subsequent investigations, analyses, the information contained in the OSHA report, and the West Virginia Order to Refit Underground Mine Shelters, MSHA has issued a Program Policy Letter (P11-V-17) which addresses further inspection and refit requirements applicable to all refuge alternatives, including: prefabricated refuge alternatives with approval granted in accordance with WV Code of State Rules §56-4-8 and accepted by MSHA in emergency response plans; prefabricated refuge alternatives without state approval but accepted by MSHA in emergency response plans and in use prior to March 2, 2009; and refuge alternatives constructed from 15-psi stoppings and accepted by MSHA in emergency response plans.
