Rupture of High Pressure Hydraulic Line

Mine Type: All Mine Types

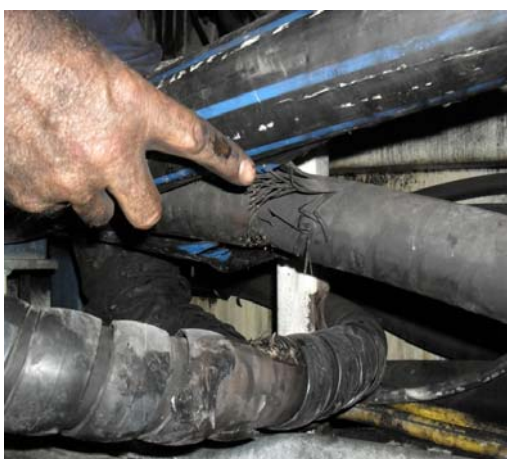
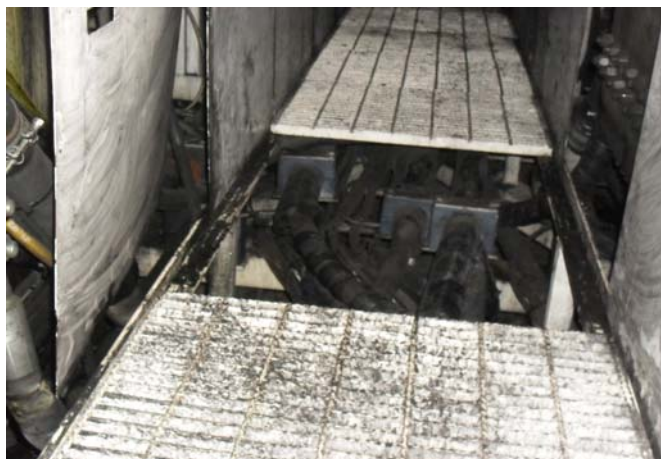
Incident: After a longwall mine lost electrical and hydraulic power on the face, an investigation found that the pump cart had suffered significant damage due to the rupture of a high pressure emulsion line. The ruptured line damaged the walkway platform (see pictures below) and an electrical cubicle; cutting power to the longwall as the walkway was ejected approximately three metres.

Cause: Hoses had rubbed together compromising the integrity of the outer casing and steel reinforcing braids.

Poor design, including hose routing, hose retention and hose segregation, were major contributing factors in the incident.

No inspection regime was in place for the hoses and other components.

In this instance, a personnel walkway was directly above the site of the hose failure and the section of walkway was ejected. Fortunately no one was in the area or on the walkway. Segregation of personnel from high pressure hoses needs to be considered in the design process.

1. Ensure the design of hose and pipe layouts eliminates contact and rubbing.

2. High pressure hoses need to be securely mounted and regularly inspected for wear and abrasion.
3. 'Introduction to site' inspections for new equipment need to consider hose and cable layout.
4. Personnel access in and around high pressure installations needs to be kept to a minimum and segregated where possible.
