Safety alert

Safety alert no. 249 (Version 1)
16 September 2010

Injury while working from a loader bucket

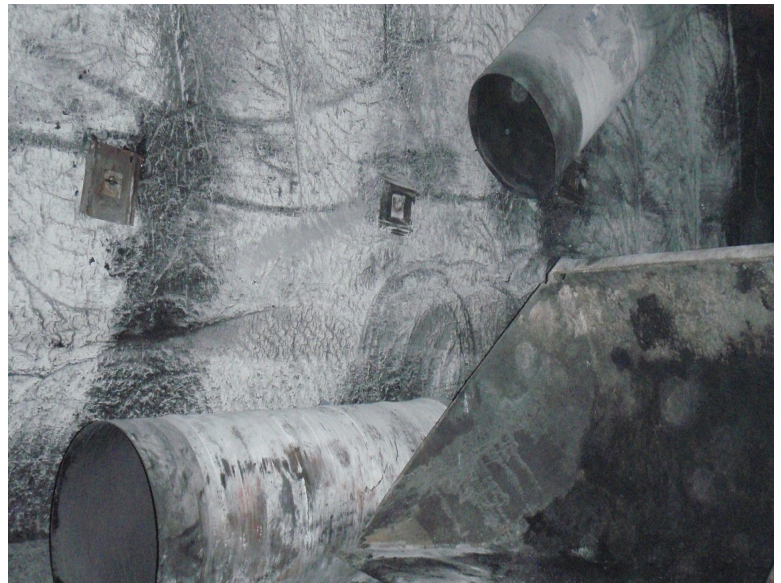
Incident: A coal mine worker fell from the bucket of a load haul dump (LHD) machine, receiving head, wrist and knee injuries. The machine's bucket was being used as a low level working platform, from which to break a line of auxiliary ventilation tubes. With the fan still running, and hence with suction pressure still on the tubes, the worker attempted to split the tubes by removing the hanging chains and pulling on the sagging tubes. When the worker eventually parted the tubes, they moved unexpectedly sending him sideways, causing him to fall from the bucket and hit his head on the floor.

Cause: The Incident Cause Analysis Method (ICAM) investigation identified the **root cause** as a **failure to follow site procedures**, as training documents for the LHD **specifically prohibited working from the bucket**. A man basket that could have been used was available nearby. Contributing factors relating to the task included a failure to identify the hazard of fan pressure acting on the tubes, and the lack of a safe work procedure for splitting the tubes.

- The bucket in this case, positioned less than 0.5 metres from the ground, clearly demonstrates that significant risk of fall injury exists even when working at low height.

1. Everyone at a mine should be fully aware of their obligations under mining safety and health legislation, including compliance with safety and health management system procedures.

2. Employers should assist by clearly communicating the 'obligations of persons generally' under mining safety and health legislation to their employees,

3. Mines should consider behavioural safety programs to reinforce the safety obligations and behavioural expectations held of persons at the mine.
4. Review availability and location of work platforms (man baskets) relative to work areas, to ensure there are sufficient available when needed.

5. Consider and review risk controls for tasks at the mine which may involve working at low height.
6. Review safe work procedures for tasks involving auxiliary ventilation systems, to ensure the hazard of potential energy from fan ventilating pressure is considered and appropriately controlled.
