INCIDENT ALERT

LOCATION: CONSTRUCTION/DELIVERY SITE
 ACTIVITY: PRODUCTION AND PROCESSING
 SUB ACTIVITY: AGGREGATE PROCESSING

ALERT STATUS: Normal
 DATE ISSUED: 16/08/2011
 INCIDENT No: 00298

Articulated Dumper Cab Overturn

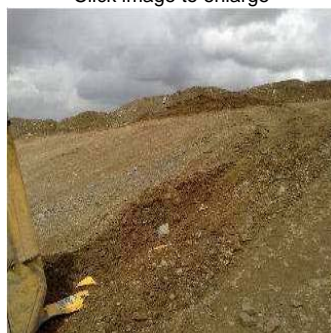
Whilst attempting to reverse down the slope the driver had his cab angled at 90 degrees to the trailer section which was positioned down the slope. Due to the width of the flat area at the top of the slope and the area being driven and turned on several times, depressions had appeared.

The front left hand side wheels were just off the flat area and on to the slope. The front left wheel went into a depression causing the cab to dip, due to this the weight of the rear body and its load caused the rear to drag the cab over and then slide approx 6 metres down the slope.

Slope

- the tip area being a more suitable grade for the operation and the operation better planned
- a more stringent inspection regime of the tip area by site managers, supervisors and drivers

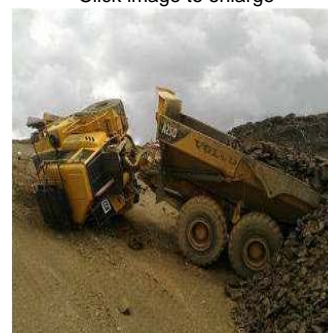
An Articulated dumper cab turned over whilst attempting to reverse down a slope with the cab at 90 degrees to the rear body. The driver suffered bruising to his right thigh and was prevented from further injury as he was wearing his seatbelt.

Overturned Cab
