## INCIDENT ALERT

LOCATION: CONSTRUCTION/DELIVERY SITE  
ACTIVITY: TRANSPORT / DELIVERY  
SUB ACTIVITY: PRODUCT DELIVERY

ALERT STATUS: Normal  
DATE ISSUED: 22/08/2011  
INCIDENT No: 00309

### Truck Mixer Driver suffers Amputation

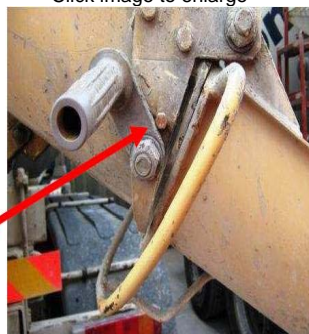
Shute with Bolt

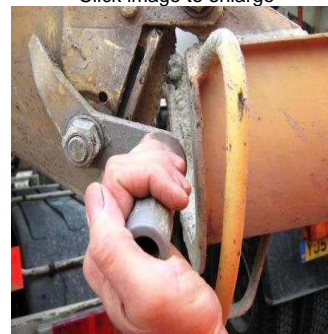
A truck mixer driver received crushing injuries resulting in the amputation of part of his little finger when the two handles in the picture came together when he operated the chute.

The bolt highlighted was missing and had not been replaced. This allowed the round bar handle on the second (lower) chute to impact against the safety catch handle on the upper chute which resulted in the injury.

Shute with Missing Bolt

The use of a small bolt to prevent the safety catch handle over rotating is being raised with the manufacturer of the mixer.

Ensure regular inspections are carried out.

Report all defects.

Ensure that remedial or repair work is promptly completed.
