Mobile crushing plant - unintended movement of tracks

Health and Safety Executive - Safety Notice	
Department Name:	Field Operations Directorate
Bulletin No:	FOD 4 - 2011
Issue Date:	2 November 2011
Target Audience:	<p>Quarries [1] , Mining [2] , Construction [3] , Demolition, Waste and Recycling [4] and Others. For the attention of owners and operators of mobile crushing plant.</p>
Key Issues:	<p>There is potential, on some mobile crushers, for unintended movement of a machine track if an earth/ground fault occurs because of damage to the outer sheath and insulation of the electrical cable that controls the proportional control valve for the track. This can result in unintended movement of the machine track(s) and the potential for injuries from being struck by or trapped by the machine. Where damage/deterioration of the electrical control cables can lead to a risk of unintended movement, the actions outlined in this safety notice should be taken.</p>

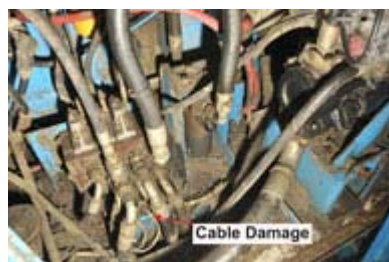
[7]

- The outer sheath and insulation of the electrical control cable had become damaged as a result of rubbing against the machine chassis.
- There was potential for damage and deterioration of the electrical control cable given the type of cabling used, its location in the engine compartment and the environment it was subject to.
- An accumulation of product debris concealed the cable.

Location of damage to cable

- Install helical sleeving (or similar) to provide additional protection to the control cables and route/secure the cables away from the machine chassis and any other potential rubbing points; and
- Consider the installation of fault monitoring to reduce the likelihood of unintended movement should an earth/ground fault occur.

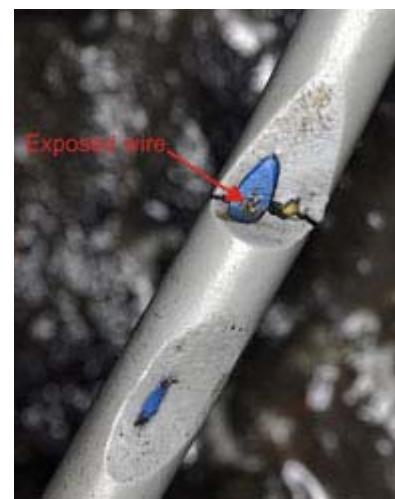
[6]

At the time of the fatal incident, inspection/maintenance work was being undertaken on the machine when the right track of the machine moved unexpectedly trapping the worker. The 'make ready' button on the machine control pendant had been pressed enabling the ground drive system. Investigation found the electrical control cable connected to the electrical actuation unit of a track valve had an exposed conductor. This meant that there was an unsafe condition whereby if the 'make ready' button had been

pressed and the exposed conductor came into contact with the machine chassis, the track would move.

Electrical control cable cleaned and magnified for illustrative purposes
