Title Grab Truck Access Ladders

Safety Alert No.

CHL 007

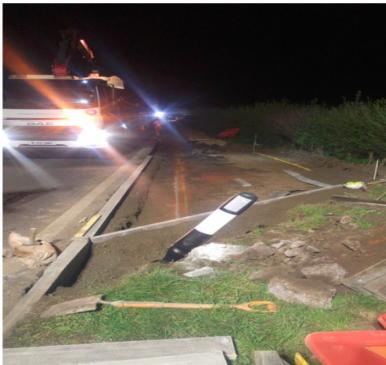
The photo to the left shows the area where the incident took place. The driver was lucky that they did not fall onto the newly installed kerb line as this could have made their injuries a lot worse.

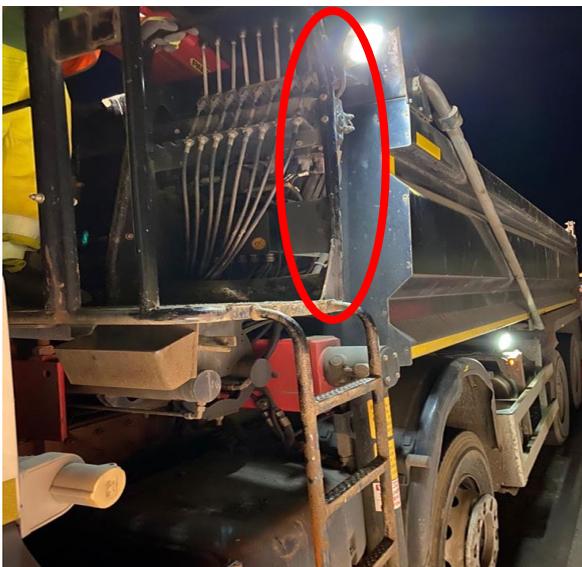
During the investigation the root cause was identified that while you can still maintain three points of contact when using the access ladder, the controls for the crane hinder the handrail which resulted in the driver's right hand slipping from the rail and consequently falling.

The highlighted area shows the crane controls restricting access to the handrail.

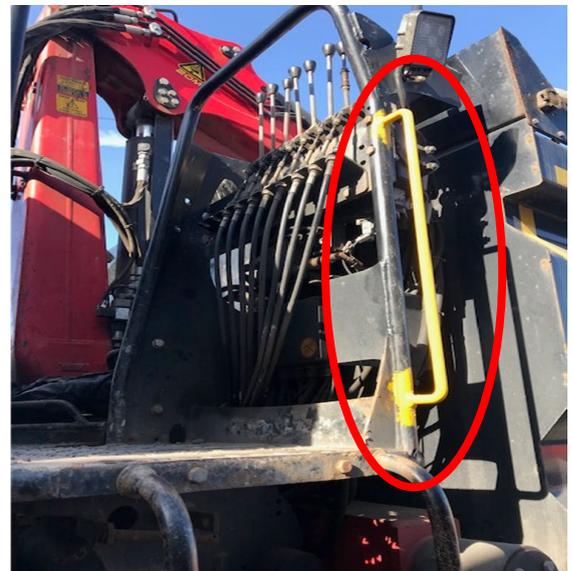
The highlighted area shows the new handrail for better access

This has now been rectified by installing an additional handle on the outside of the rail so the driver can use this instead of having to reach over the crane controls to gain access to the working platform.
