# NZ Safety Alert

January 2020

## Crush injury while welding

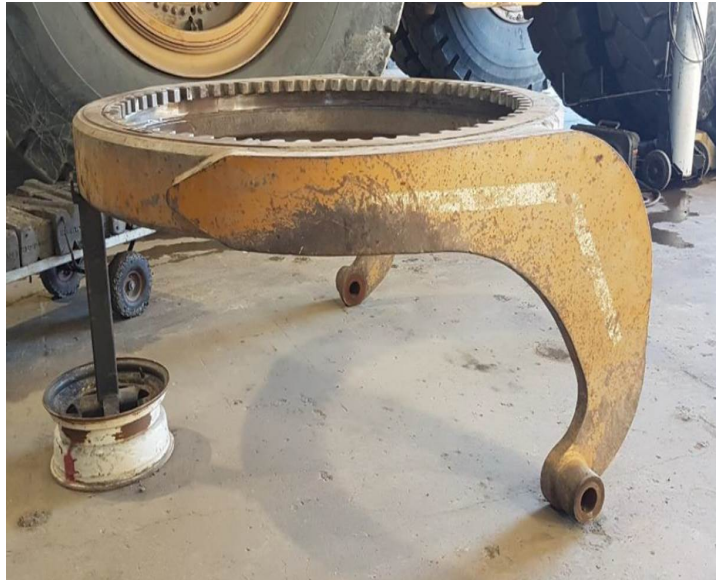
A worker was welding on a grader blade turn circle that was not chocked adequately. The stand failed and the turn circle rotated downwards onto the concrete causing severe crush injuries to his feet.

Some machinery observed has been suspended under its own power (i.e. lifted with the equipment's own floor jacks). Workers have also been seen working under elevated dump truck trays where they are only relying on the hydraulic system. The equipment was also not isolated.

1. Where equipment is elevated and crush or entrapment hazards exist, all plant is isolated prior to commencing work on it.
2. Fit for purpose chocking and lifting equipment is used for maintenance tasks.
3. Maintenance is always conducted in accordance with Original Equipment Manufacturers specifications.
4. Equipment is never suspended under its own power (i.e. lifted with the equipment's own floor jacks).
5. Regular workplace inspections are conducted to check equipment and to ensure procedures are being followed.
