INCIDENT ALERT

LOCATION:	CONCRETE PRODUCTS	ALERT STATUS:	Normal
ACTIVITY:	MANUAL HANDLING AND STORAGE	DATE ISSUED:	27/04/2016 15:34:34
SUB ACTIVITY:	N/A	INCIDENT No:	01429

Catastrophic failure of clamp on forklift

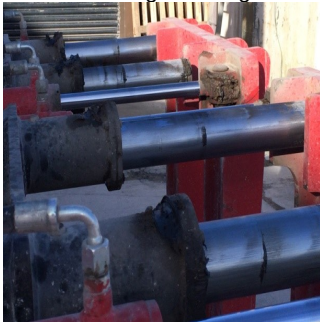
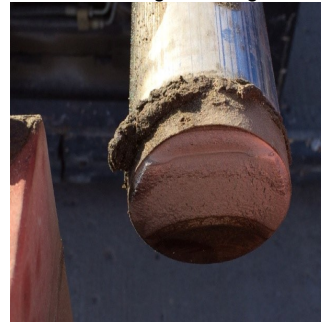
A clamp which was attached to a Linde HD 50 forklift failed catastrophically when a steel rod sheared. This resulted in a pack being dropped as it was being placed on the ground. The incident could have been much worse as packs can be stacked 4 to 5 cubes high at full extension. No injury occurred during the incident, but the potential was far greater. Investigations identified that the clamp and truck had been in service just under three years and that the clamp attachment had been serviced within the last 9-10 months.

Sheared rod on clamp

Learning Points: • The service of the clamp attachment and inspection routines failed to pick up this fault • Existing clamp attachments should be checked / inspected by NDT to ensure they are crack free
Actions: • Amend service routine to cover NDT of area of rod that failed • Review frequency of inspection and service
