### SECTION A - INCIDENT ALERT

Incident no: INC-0161335	Date: 01/03/2021	Time: 1509hrs
Department: Zinc	Asset name : George Fisher Mine	Country: Australia
Incident Title: Operator working at height on top of a loader with no fall restraint and engine running.		
Related Hazard: 2. Working at Height	For "Other" describe:	
Process Safety Management related Yes <input type="checkbox"/> No <input checked="" type="checkbox"/>	Mobile Equipment and Energy Isolation	
The incident involved: <input checked="" type="checkbox"/> Employee <input type="checkbox"/> Contractor:	Legal Consulted (Actual Cat 4 & 5 incidents): <input type="checkbox"/> Yes <input checked="" type="checkbox"/> No

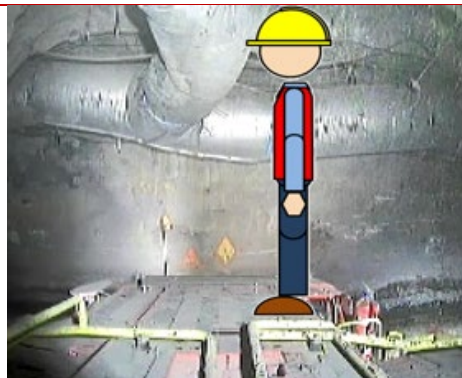
An Operator was observed on video footage exiting the cabin and climbing on top of an underground loader via the articulation area/midship steps and rear steps to adjust vent.

Whilst Operator was on top of the loader, the engine was still running. The Operator was not safeguarded by a fall prevention system or protection device.

On review of the footage, the Operator was observed to conduct the activity on more than one occasion.

Possibility of a fall from of over 2m height onto the ground.

Possibility of crushing injuries whilst entering articulation area with engine still running.

Operator stood-down pending investigation.

The incident investigation commenced.
