# H&S Alert

## FIRE BELOW GROUND ON TUNNEL TRANSPORT VEHICLE

Date of incident:	10/05/2022 at 19:30pm	Incident type:	HiPO
Incident ref:	INC12407	Contractor:	ALIGN
Location:	South Portal, Chiltern Tunnel	Keyword search	Fire, Tunnel

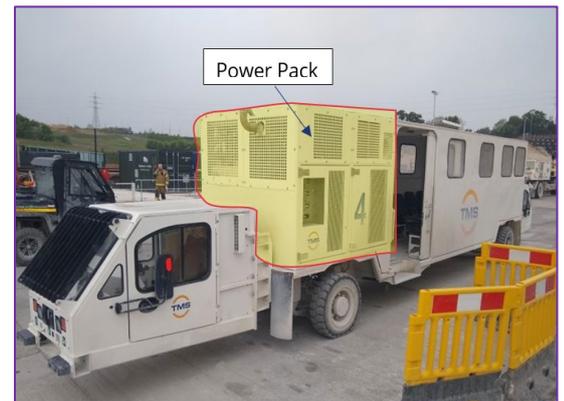
A purpose-built tunnel transport vehicle was taking the nightshift crew to their place of work along the tunnel and the Tunnel Boring Machine (TBM). During one passenger drop-off the vehicle developed a fault, and the team visually identified a fire in the power pack. The operator notified Site Incident Control (SIC) and instructed the passengers to evacuate the vehicle and to exit the tunnel. The vehicle operator manually activated the fitted fire fighting system and the fire was suppressed. As the crew made their escape the fire in the power pack reignited. In accordance with emergency plans the personnel already stationed ahead on the TBM were instructed to move to the refuge chamber.

The fitted firefighting system within the vehicle power pack was activated by the operator. All personnel disembarked vehicle and walked back to Portal entrance. The agreed site emergency response plan was initiated. The TBM crew (3x) on changeover shift were instructed to enter one of the specialist refuge chambers on board the TBM and blue light support was called.

Carry out detailed inspections within the engine compartments & power packs within all tunnel vehicles and to identify any potential issues with the integrity, routing and securing of fuel lines, electrical cables, and hydraulic hoses, particularly focusing on the proximity of heat sources, the possibility of wear from lines rubbing together, rubbing against sharp edges and the correct termination of all lines, hoses and cables.

Consider the design element regarding separation of fuel systems and electrical sources, such as fuel hoses / tanks and electrical batteries.

Review the provision of any fitted firefighting system to ensure that it meets the expectation and the fire risk assessment for the tunnel vehicles and the tunnel.

Regard should be paid to any fitted firefighting systems and cool and quench principles as referred to within in the BS6141 Code of Practice for Tunnelling and ensuring that firefighting methods are consistent with the ... arrangements and the expectations of the emergency response strategy.
