NZ Safety Alert

9 June 2023

Failure to lower safety legs

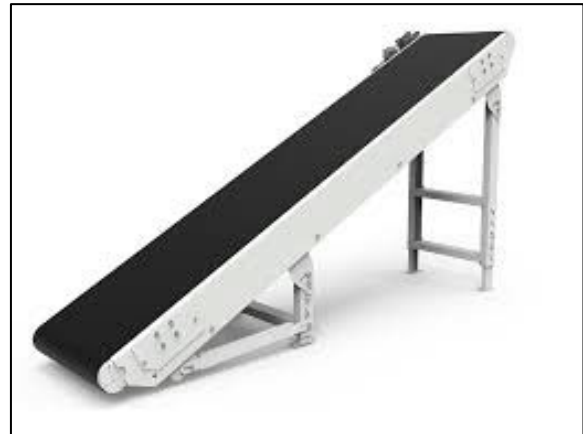
A fitter was working on a mobile crusher in the workshop and lowered the front belt to make it easier for fitters to work on it.

The fitter had lowered the legs earlier but when he shifted the machine into the shed out of rain, he forgot to put the legs down again as he got distracted doing other work resulting in the belt frame collapsing.

While no-one was injured this could have seriously injured the contractor working on the belt.

1. No-one works near or under a suspended load that is not adequately secured to prevent it from falling.
2. Regular workplace inspections are conducted to identify unsafe behaviour and other activities that could put workers at risk of harm.
3. All mobile equipment is maintained in accordance with Original Equipment Manufacturer (OEM) requirements, including use of all safety equipment.
