# NZ Safety Alert

## Oil sprays from exhaust

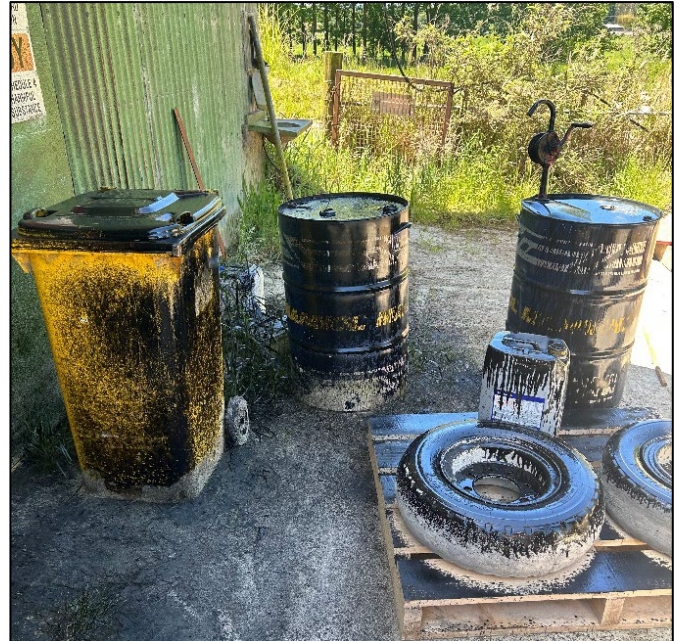
A forklift needed engine oil, but instead 10 litres of hydraulic oil was poured directly into the engine. The engine started rumbling and was shut off after approximately 30 seconds.

The excess oil was sprayed from the exhaust of the forklift and created a large cloud of smoke. Another worker who saw the smoke grabbed a fire extinguisher to put out what he thought was a fire.

1. All containers are adequately labelled so that the contents within the container are clearly visible.
2. All plant has clear labelling for refilling of fuel, hydraulic oil, engine oil etc.
3. The location of all fuels, oils etc. is clearly labelled and understood by all workers.
4. Operator manuals are available so that workers can check on requirements for refuelling and topping up oils.
