NZ Safety Alert

21 August 2020

Uncontrolled movement of truck

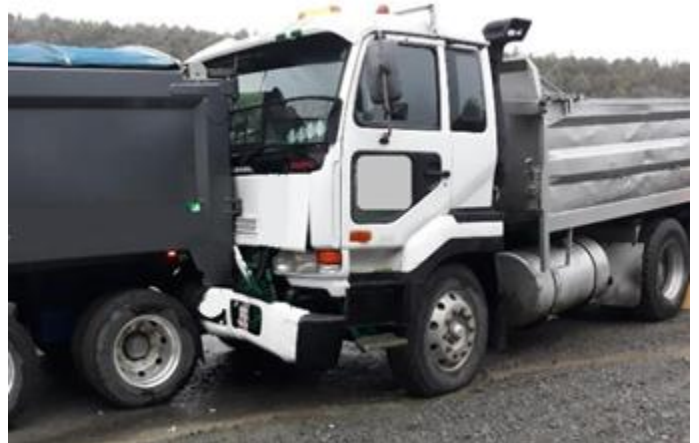
A customer's truck pulled into the tarping bay area to tie down his tarpaulins before leaving a quarry. This area is on a downward gradient and as the driver got out of his truck, he accidentally released the parking brake. The truck rolled into the rear end of the truck and trailer which was parked in front of him.

The area contains a bathroom facility and office block and drivers and others are frequently on foot. As a result, this could have easily resulted in a severe injury.

1. You review parking areas to ensure they are adequately bunded and designed so that vehicles park side by side.
2. All vehicles are fundamentally stable before operators exit the vehicle. This may include backing vehicles into a depression, the use of chocks, ensuring ground is level where possible, and that braking systems are fully engaged.
3. Mobile equipment operators, including contractors, are trained and assessed as competent to use all equipment they are operating.
