INCIDENT ALERT

LOCATION: AGGREGATE DREDGER
ACTIVITY: MAINTENANCE & HOUSEKEEPING
SUB ACTIVITY: N/A

Confined Space - Serious Near Hit

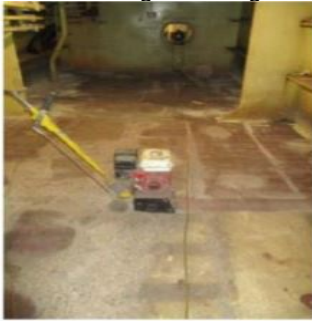
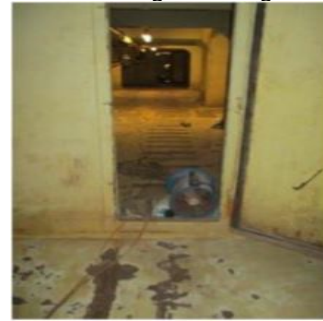
The task involved using a power scarifier to clear paint and rust from steel surfaces. The tank was gas free and certificated before work commenced with a yard entry certificate running for 24 hours. Initially the contractors used an electric 110v scarifier unit, but as they moved along the voids they encountered power drop issues on the electric unit with the length of power leads used. The contractors changed from the electric motor unit to a petrol engine unit and continued working throughout the day.

On leaving site they reported feeling dizzy and unwell and visited the local hospital, where they were found to have high carbon monoxide blood readings and were placed on oxygen for 2 hours before being discharged. The carbon monoxide was created from the exhaust of using a petrol machine in an enclosed space.

- No company personnel were informed of the near hit until the following day;
- Risk assessment did not include the use of power tools or the petrol scarifier;
- The permit issued from the yard did not include petrol equipment.
