Hand caught in conveyor

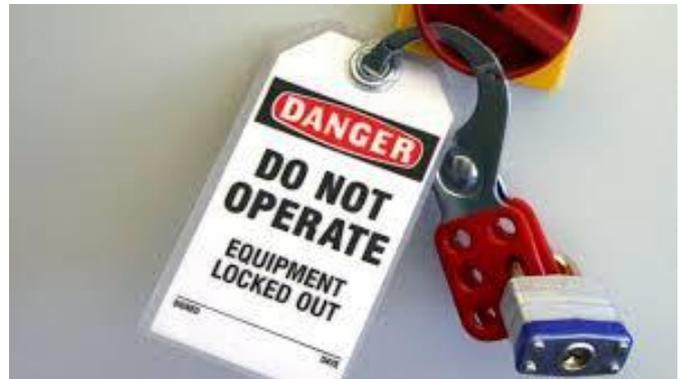
A worker locked out the plant prior to removing area guards and hosing under the plant. The operator restarted the plant after completing the clean-up and detected an unusual noise around a conveyor. He entered the guarded area of the plant to investigate the noise without turning off the plant or isolating the power. The worker tripped and planted his hand on the moving conveyor. His hand became trapped between the belt and the conveyor structure resulting in 3 broken fingers, lacerations and associated abrasions. The injury resulted in major reconstruction surgery of the affected tendons and a near amputation.

- **All guards are put back in place following maintenance and/or clean-up, prior to removing locks and re-energising the plant.**
- **Effective risk assessment/s are completed, and checked, prior to commencing any task. Adequate controls are put in place to avoid entanglement risks.**
- **All workers are trained, and re-trained as required, in isolation procedures and safe work procedures generally.**
- **You supervise, and conduct physical checks, to ensure workers are completing the task/s in accordance with safe work procedures and/or risk assessments completed.**
