INCIDENT ALERT

LOCATION:	CONTRACTING - ON-HIGHWAY	ALERT STATUS:	Normal
ACTIVITY:	MAINTENANCE & HOUSEKEEPING	DATE ISSUED:	14/06/2019 09:40:40
SUB ACTIVITY:	N/A	INCIDENT No:	01515

Failure of Suspension Airbag

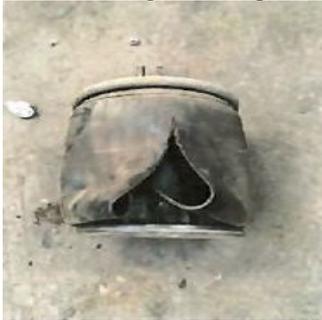
The injured party (IP) was carrying out maintenance work on the underside of a trailer unit. Near the end of the maintenance, the IP was stood in the pit working on the underside of the trailer near the axle, when the suspension airbag to the right exploded.

The result of this release and the noise created was sufficient enough to cause temporary hearing loss and strained the IP's neck area. The IP was treated by the first aider on site and later attended hospital. The incident caused no permanent damage to the ear and normal hearing returned a short time after. The failure of the suspension bag was caused by either a stone or other object that was trapped between the pedestal and the air bag, causing a cut, allowing the bag to fail under pressure. After researching similar events, the potential for this incident to have caused far greater levels of injury cannot be understated. Trauma because of airbag explosion/deployment is not uncommon - injuries have usually been sustained because of failure or misuse of the system. In one incident, a 53-year-old man was attempting to repair the suspension airbag on the undercarriage of his articulated vehicle. To save time he decided not to raise the vehicle. The air bag spontaneously ruptured causing massive trauma to the patient. His injuries were facial lacerations, a fractured mandible, loss of teeth, displacement of his denture and would have needed ongoing rehabilitation and support. The patient in this case was extremely fortunate.

- Understand the potential of suspension airbags to cause harm - For underside 'suspension airbag inspections', a face shield and hearing protection must be worn at all times, until the inspection is complete. - When general maintenance is being undertaken on the underside of the trailer, the air must be fully released from the suspension system - Eliminate/Reduce the risk where practicable, removal of air, pressure, stored energy - always follow the correct procedures - Treat any pressurised or closed pressurised system with care and if in any doubt as to the systems integrity, stop and report this to supervisors/managers immediately
