# NZ Safety Alert

December 2018

## Loss of control of loader

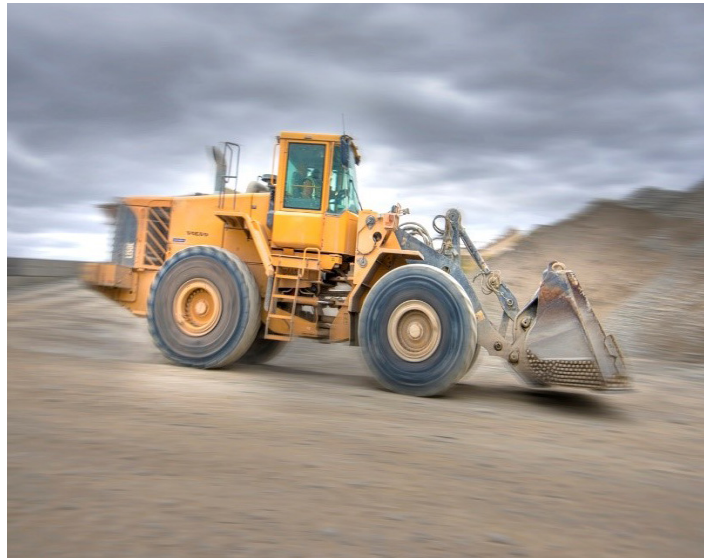
While driving a front-end loader down a ramp, the operator experienced problems with the gears. He bumped the controls causing the bucket to suddenly lower bringing the loader to a sudden stop. The driver was not wearing his seatbelt and was thrown into the windscreen, hitting his head.

1. Procedures are in place to ensure operators of mobile equipment wear seatbelts at all times while operating the equipment. Training, awareness, supervision and possibly disciplinary action will need to be used to ensure compliance.
2. Operators are trained and assessed as competent to operate mobile equipment. This needs to include model/equipment specific training and assessment.
3. All activities are adequately supervised, including workplace inspections and task observations.
4. Lessons from incidents, including learnings are shared with all workers.
