WEEKLY INCIDENT SUMMARY

Week ending Friday 24 May 2019

Mine safety reference ISR19-20

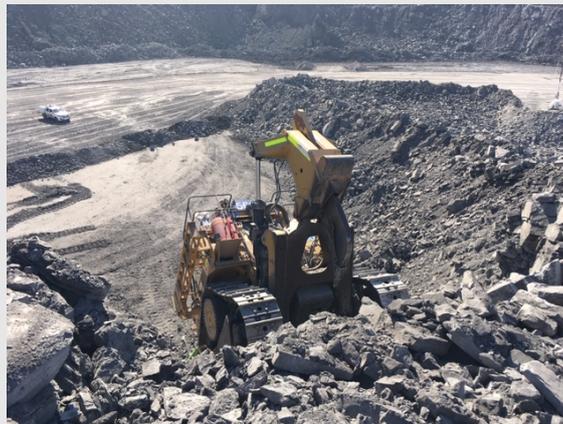
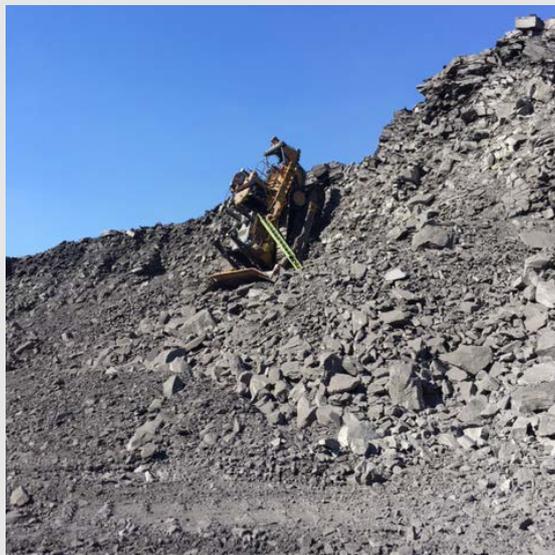
Dangerous incident
IncNot0034645

A dozer was preparing an access and windrow at an open cut coal mine at night. The operator became disorientated and inadvertently trimmed over the rill face. The operator was able to bury the blade into the rill material and halt the machine. The mine's emergency response team retrieved the operator, who was uninjured.

When working at night, work areas must be inspected, and potential hazards must be identified and communicated to relevant workers. Suitable windrow and lighting should be installed to define the work area.
