Laceration to Wrist by Grinder

Incident Description

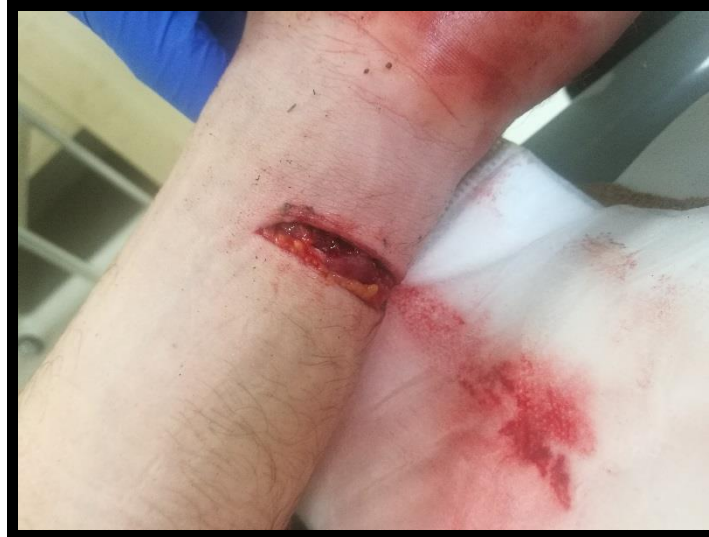
A contractor was cutting channels using a cordless 5 inch grinder on a plastic pit in preparation for installation. During operation the grinder has kicked back when cutting across a groove in the pit shell and the grinder blade has made contact with the workers left arm.

The worker sustained a laceration approximately 50mm in length across his left wrist. The laceration severed his ulnar nerve, ulnar artery and flexor tendon, which required three (3) days hospitalisation and surgery. The worker is expected to make a full recovery after approximately 12 weeks rehabilitation.

- Grinder did not have an auxiliary handle attached
- Grinder operation was being performed one handed, other hand was bracing the pit shell
- Grinder was not appropriately guarded, and did not have a Deadman switch
- SHEWMS 15 – Working with Plant and Power Tools was not followed

- Issued a (lifetime) Prohibition Notice to Contractor advising all power tools must be used in accordance with Manufacturer’s instructions
- Contractor stood down
- An Improvement Notice was issued to ensure Notifiable Incident reporting timeframes are met, and Contractors are aware of their obligation to preserve the site of the incident

- Contractors **must** adhere to the Prohibited and Restricted Items list – This procedure to be re-communicated through safety briefings and tool box talks
- Employer to ensure all grinders meet operational requirements, verified during site inspections
- Front line leaders must ensure that SHEWMS are being followed for all activities
- Incident Notification Management Procedure modified to address Improvement notice
- Face to Face Induction enhanced to provide clear and concise to contractors on their requirement to preserve incident sites which meet the Legislative Notifiable criteria
