SAFETY ALERT

SEATBELTS IMPORTED BY BVL (BUSINESS VENTURES LIMITED)

Updated November 2018

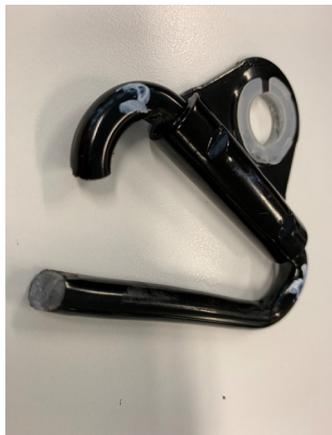
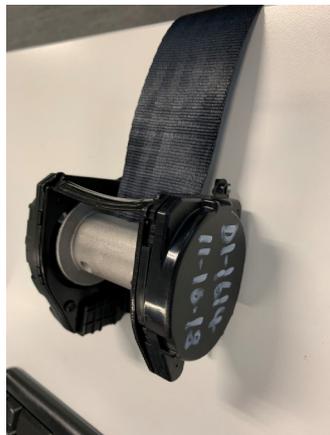
In crash testing, failure occurred in the shoulder anchor point (D-ring) and the retractor mechanism failed to lock and prevent runout of the belt.

- Review your vehicle and determine if your three-point seatbelts have labels that say BVL. If in doubt, a vehicle inspector (such as a WoF or CoF inspector) will be able to identify them.
- If these belts are fitted in the driver's seat, our advice is to not use the vehicle until replacements are fitted. If fitted in other seating positions, our advice is to not allow passengers to use those seats.
- If your vehicle has an affected seatbelt please contact the reseller from whom you purchased the belt for advice

- Vehicle inspectors have been instructed to fail a vehicle for its WoF or CoF inspection if these seatbelts are identified in your vehicle.
- Feedback regarding BVL seatbelts or all other enquiries or questions related to this should be directed to the Transport Agency on 0800 699 000.

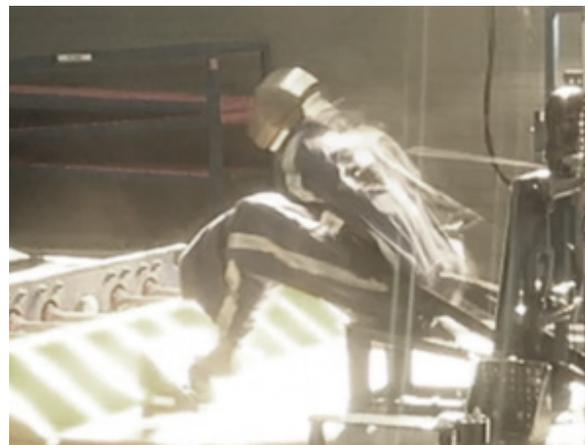
In the 50km/h test, the mannequin flies forward after the seatbelt fails.
