Worker falls from truck body

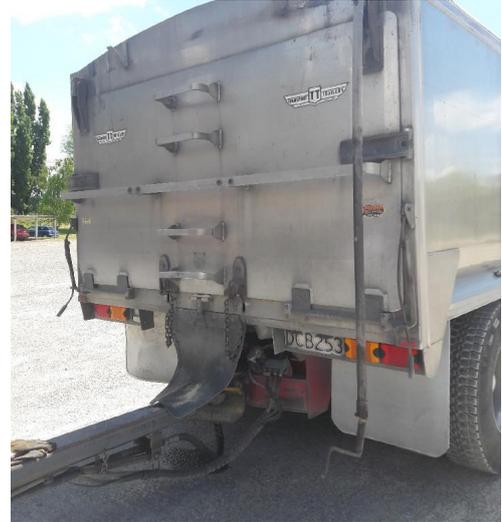
A visiting truck driver was climbing a ladder on the trailer of his truck to put the tarp roller handle into position. The handle did not position correctly, and the driver slipped, falling from the bin onto the ground. Injuries sustained included loss of consciousness and bruising to the ribs.

1. Fall hazards such as slope stability, unsecured tools, screens etc., trip hazards and areas where workers can fall from height are identified in risk assessments.
2. Adequate and effective controls are in place to ensure no-one is exposed to the fall hazards identified.
3. Ensure all visitors, contractors and their employing companies understand the need to use industry best practice when working around their vehicles.
4. All activities are adequately supervised, including workplace inspections and task observations
