Worker injures hand when material falls on it

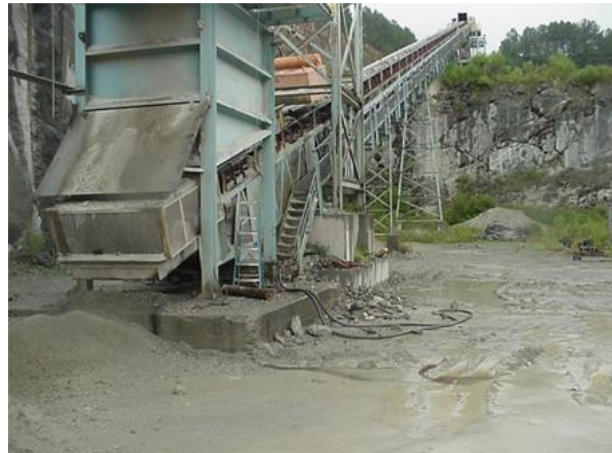
In order to conduct maintenance, a worker needed to remove guards from the tail drum of a conveyor. There was a lot of spillage built up inside the guard. As the worker removed the second guard all the weight of the spillage material rested on the last bolt to be removed. The worker put his arm underneath the guard to unscrew the bolt using a rattle gun when the bolt came out and the guard dropped on top of his right hand. His hand became swollen and first aid treatment was administered immediately.

- **Risk assessments are conducted before any non-standard task is undertaken to identify potential hazards.**
- **Adequate and effective controls are in place to ensure no-one is exposed to the hazards associated with objects falling on them.**
- **Regular workplace inspections are conducted to identify spillage and poor housekeeping in work areas which could expose workers to fall hazards.**
- **Adequate time and resources are provided for all tasks, particularly where workers are required to lift potentially heavy objects.**
